Access Compliance Report

Public Rights-of-Way

(Curb Ramps)

Intersection ID: 3155	Main Street: LENOX_HILL_PL	Cross Street: YANDEM_CT	Location: SW
ADA ID: 93297272E927	Ramp Type: Perp	Initial Pass/Fail: Fail	Overall Compliance: No
			Severity Score: 8.75

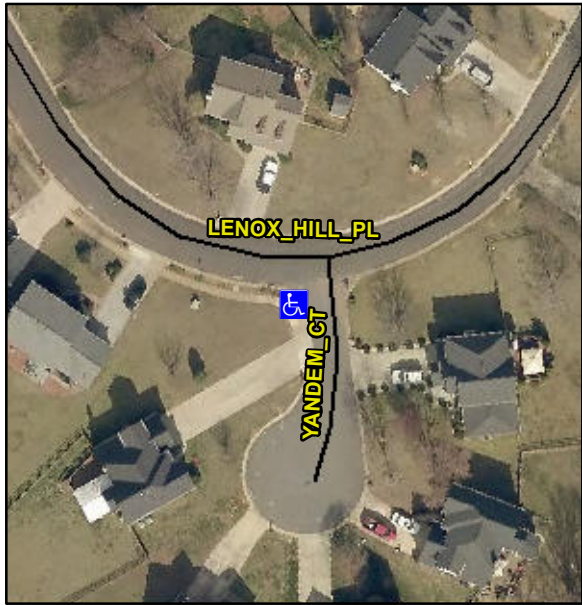
Possible Solutions:		Compliance	Description	Data	Compliance	Description	Data
	Remove & Replace Entire Ramp.		N/A	Ramp Length (in)	100.0	Yes	Ramp Slope (%)	5.0
			No	Ramp Width (in)	45.0	Yes	Ramp XSlope (%)	0.3
			N/A	Flare Type LT	N/A	N/A	Flare Type RT	N/A
			N/A	Flare Slope LT (%)	N/A	N/A	Flare Slope RT (%)	N/A
			N/A	Flare Traversable LT?	N/A	N/A	Flare Traversable RT?	N/A
			N/A	Landing Length (in)	N/A	N/A	DWS Provided?	N/A
			N/A	Landing Width (in)	N/A	N/A	DWS Contrast?	N/A
			N/A	Landing Slope (%)	N/A	N/A	DWS Length (in)	N/A
			N/A	Landing X Slope (%)	N/A	N/A	DWS Full Width?	N/A
Surveyor Notes:		N/A	N/A	Landing Curb? (Y/N)	N/A	N/A	DWS Offset (in)	N/A
PROW/ADA:		Not Found, R304.5.1	N/A	Shared Landing?	N/A			
			N/A	Gutter Ponding?	N/A	N/A	Gutter Slope (%)	N/A
			N/A	Gutter Lip Ht (in)	N/A	N/A	Gutter X Slope (%)	N/A

N/A	Painted X Walk1?	No	N/A	Painted X Walk2?	N/A
				X Walk 1 Direction	To E		X Walk 2 Direction	N/A
			N/A	X Walk 1 Width (in)	N/A	N/A	X Walk 2 Width (in)	N/A
				X Walk 1 Slope (%)	3.2		X Walk 2 Slope (%)	N/A
				X Walk 1 X Slope (%)	0.5		X Walk 2 X Slope (%)	N/A
			N/A	Ramp inside XWalk1?	N/A	N/A	Ramp inside XWalk2?	N/A
				Road Slope (%)	N/A	N/A	Clear Space?	N/A
				Road X Slope (%)	N/A	N/A	Clear Space to XWalk (in)	N/A
			N/A	Any Obstructions?	N/A	N/A	Storm Grate/Utility Hazard?	N/A
				Obstruction Type			Storm Grate/Utility Type	
					N/A			N/A
						Yes	Surface Condition? (G/P)	Good
Total Cost:		\$ 1850.00						
Street 1 Name		YANDEM CT						
Stop Condition-Street 2		StopSign						
Street 2 Name		N/A						
Stop Condition-Street 1		N/A
