Access Compliance Report

Public Rights-of-Way

| Intersection ID: 12998 | Main Street: E_5TH_ST | Cross Street: N_MCDOWELL_ST | Location: W |
| ADA ID: 93371C8F026D | Ramp Type: Combination2 | Initial Pass/Fail: Fail | Overall Compliance: No |

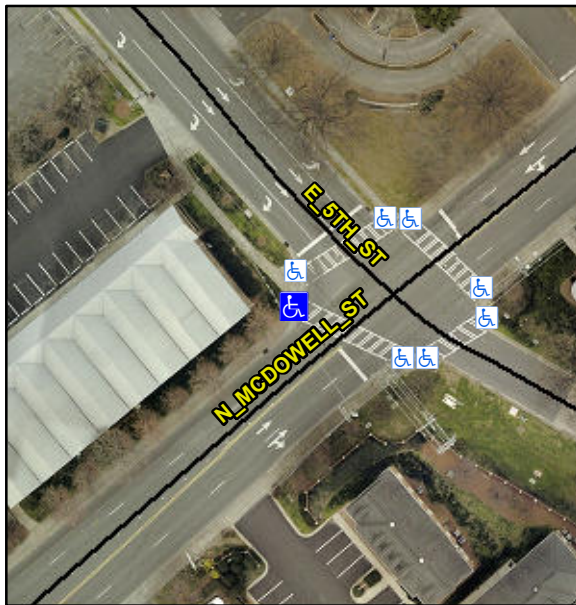
Not Found, R304.3.2, R304.5.3

| Compliance | Description | Data | Compliance | Description | Data |
|---|---|---|---|---|---|
| N/A | Ramp Slope LT (%) | N/A | No | Ramp Slope RT (%) | 9.0 |
| N/A | Ramp XSlope LT (%) | N/A | No | Ramp XSlope RT (%) | 3.5 |

Possible Solutions:

Remove & Replace Entire Ramp.
