Access Compliance Report

Public Rights-of-Way

(Curb Ramps)

Intersection ID: 46146	Main Street: ROCKY_FORD_CLUB_RD	Cross Street: BEAVER_CREEK_DR	Location: NE
ADA ID: 9338B510873F	Ramp Type: BlendTrans1	Initial Pass/Fail: Fail	Overall Compliance: No
Codes/Mitigation Info/Possible Solution		Field Measurements/Component Compliance	
Severity Score: 1.25

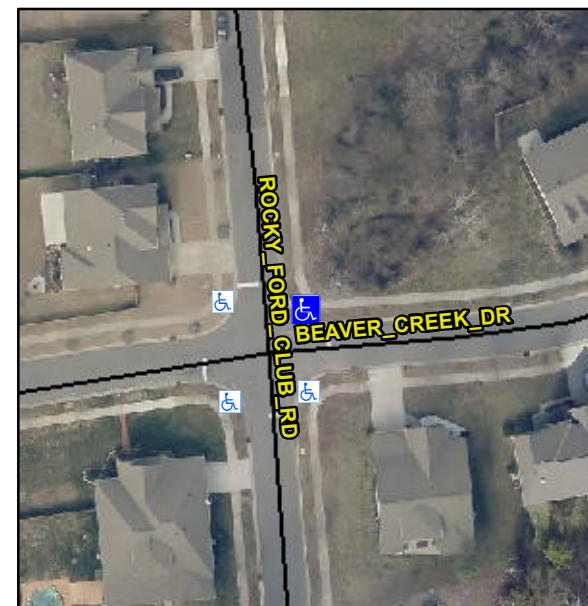
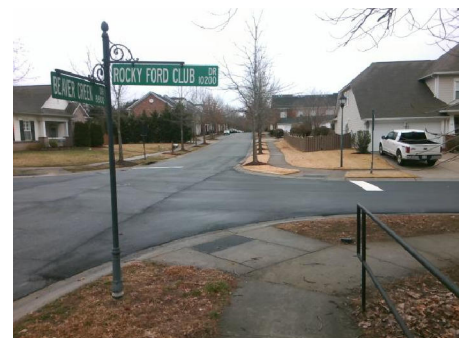
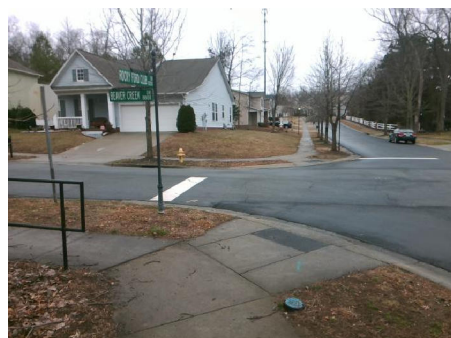
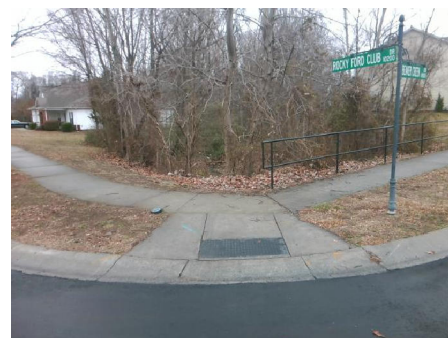
Not Found, R304.5.3

Compliance	Description	Data	Compliance	Description	Data
N/A	Ramp Length (in)	73.5	Yes	BlendTrans Slope (%)	3.1
Yes	Ramp Width (in)	48.0	No	BlendTrans XSlope (%)	2.1
N/A	Flare Type LT	N/A	N/A	Flare Type RT	N/A
N/A	Flare Slope LT (%)	N/A	N/A	Flare Slope RT (%)	N/A
N/A	Flare Traversable LT?	N/A	N/A	Flare Traversable RT?	N/A
N/A	Landing Length (in)	N/A	N/A	DWS Provided?	N/A
N/A	Landing Width (in)	N/A	N/A	DWS Contrast?	N/A
N/A	Landing Slope (%)	N/A	N/A	DWS Length (in)	N/A
N/A	Landing X Slope (%)	N/A	N/A	DWS Full Width?	N/A
N/A	Landing Curb? (Y/N)	N/A	N/A	DWS Offset (in)	N/A
N/A	Shared Landing?	N/A			
N/A	Gutter Ponding?	N/A	N/A	Gutter Slope (%)	N/A
N/A	Gutter Lip Ht (in)	N/A	N/A	Gutter X Slope (%)	N/A
N/A	Painted X Walk1?	No	N/A	Painted X Walk2?	No
	X Walk 1 Direction	To W		X Walk 2 Direction	To S
	X Walk 1 Width (in)	N/A		X Walk 2 Width (in)	N/A
	X Walk 1 Slope (%)	0.7		X Walk 2 Slope (%)	4.4
	X Walk 1 X Slope (%)	3.1		X Walk 2 X Slope (%)	0.2

N/A	Ramp inside XWalk1?	N/A	N/A	Ramp inside XWalk2?	N/A
	Road Slope (%)	1.9		Clear Space?	N/A
	Road X Slope (%)	3.9	N/A	Clear Space to XWalk (in)	N/A
N/A	Any Obstructions?	N/A	N/A	Storm Grate/Utility Hazard?	N/A
	Obstruction Type			Storm Grate/Utility Type	
		N/A			N/A
			Yes	Surface Condition? (G/P)	Good
			No	Curb Slope (%)	7.7

Remove & Replace Curb Ramp With Two New Directional Ramps or Equivalent.
