# Access Compliance Report

## Public Rights-of-Way

### (Curb Ramps)

| Intersection ID: 14382 | Main Street: BROOKHILL_RD | Cross Street: REMUS_RD | Location: S |

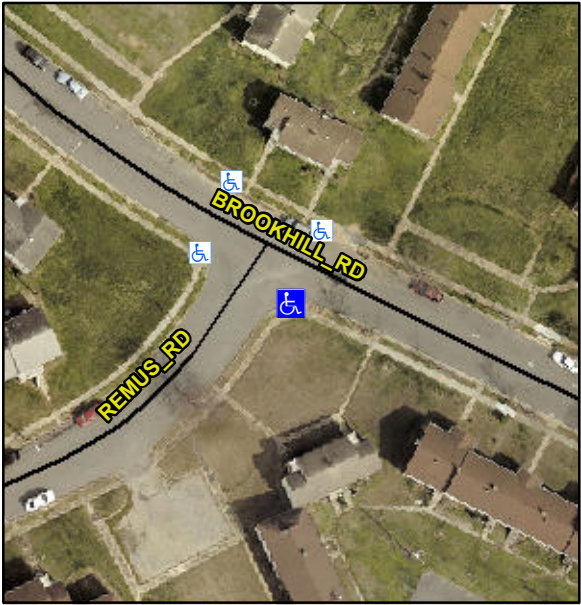
| ADA ID: 934CD9D58BE8 | Ramp Type: PerpDiag | Initial Pass/Fail: Fail | Overall Compliance: No |

| <p>Surveyor Notes:</p> <p>N/A</p> <p>PROW/ADA:</p> <p>Not Found, R304.5.1, R304.5.3</p> | | | No | Ramp Width (in) | 43.0 | No | Ramp XSlope (%) | 9.0 |

| | Remove & Replace Curb Ramp With Two New Directional Ramps or Equivalent. | | N/A | Ramp Length (in) | 86.0 | Yes | Ramp Slope (%) | 6.4 |
