Access Compliance Report

Public Rights-of-Way

(Curb Ramps)

Intersection ID: 31656	Main Street: CALTON_LN	Cross Street: CRYSTAL_ERICA_LN	Location: NE
ADA ID: 934F5F1F968C	Ramp Type: Combination1	Initial Pass/Fail: Fail	Overall Compliance: No
			Severity Score: 58.75

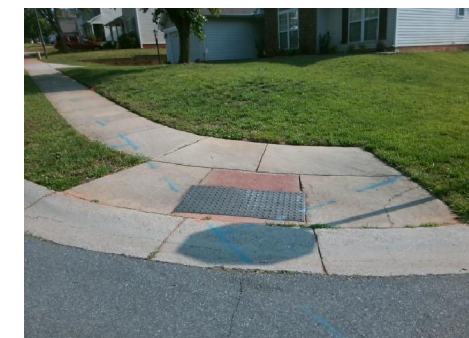
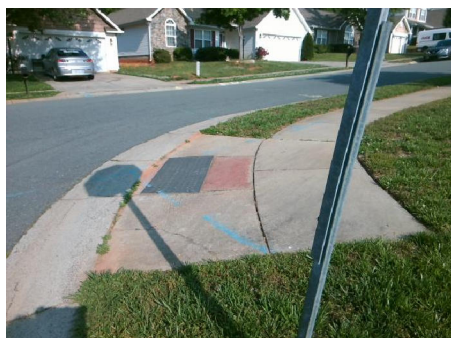
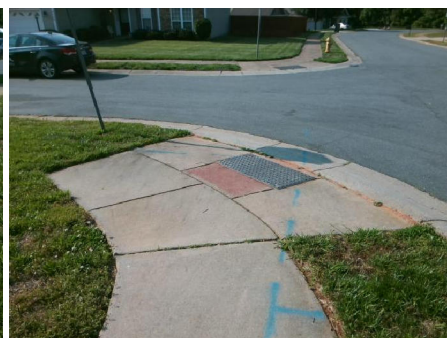
Not Found, R304.5.1, R304.5.3, R304.3.2

Compliance	Description	Data	Compliance	Description	Data
N/A	Ramp Length LT (in)	45.0	N/A	Ramp Length RT (in)	N/A
Yes	Ramp Width LT (in)	48.0	N/A	Ramp Width RT (in)	N/A
No	Ramp Slope LT (%)	13.4	N/A	Ramp Slope RT (%)	N/A
No	Ramp XSlope LT (%)	9.8	N/A	Ramp XSlope RT (%)	N/A
N/A	Ramp Length (in)	51.0	Yes	Ramp Slope (%)	6.3
No	Ramp Width (in)	42.0	No	Ramp XSlope (%)	8.1
N/A	Flare Type LT	N/A	N/A	Flare Type RT	N/A
N/A	Flare Slope LT (%)	N/A	N/A	Flare Slope RT (%)	N/A
N/A	Flare Traversable LT?	N/A	N/A	Flare Traversable RT?	N/A
N/A	Landing Length (in)	N/A	N/A	DWS Provided?	N/A
N/A	Landing Width (in)	N/A	N/A	DWS Contrast?	N/A
N/A	Landing Slope (%)	N/A	N/A	DWS Length (in)	N/A
N/A	Landing X Slope (%)	N/A	N/A	DWS Full Width?	N/A
N/A	Landing Curb? (Y/N)	N/A	N/A	DWS Offset (in)	N/A
N/A	Shared Landing?	N/A			
N/A	Gutter Ponding?	N/A	N/A	Gutter Slope (%)	N/A
N/A	Gutter Lip Ht (in)	N/A	N/A	Gutter X Slope (%)	N/A
N/A	Painted X Walk1?	No	N/A	Painted X Walk2?	N/A

X Walk 1 Direction	To W		X Walk 2 Direction	N/A
	X Walk 1 Width (in)	N/A		X Walk 2 Width (in)	N/A
	X Walk 1 Slope (%)	3.2		X Walk 2 Slope (%)	N/A
	X Walk 1 X Slope (%)	4.5		X Walk 2 X Slope (%)	N/A
N/A	Ramp inside XWalk1?	N/A	N/A	Ramp inside XWalk2?	N/A
	Road Slope (%)	N/A		Clear Space?	N/A
	Road X Slope (%)	N/A	N/A	Clear Space to XWalk (in)	N/A
			N/A	Any Obstruction?	N/A
				Obstruction Type	N/A
			N/A	Storm Grate/Utility Hazard?	N/A
				Storm Grate/Utility Type	N/A
Yes	Surface Condition? (G/P)	Good			
	Curb Slope (%)	13.8

Remove & Replace Entire Ramp.

\$ 1800.00
