# Access Compliance Report

## Public Rights-of-Way

### (Curb Ramps)

| Intersection ID: 16273 | Main Street: HARTFORD_AV | Cross Street: MAYFIELD_AV | Location: E |

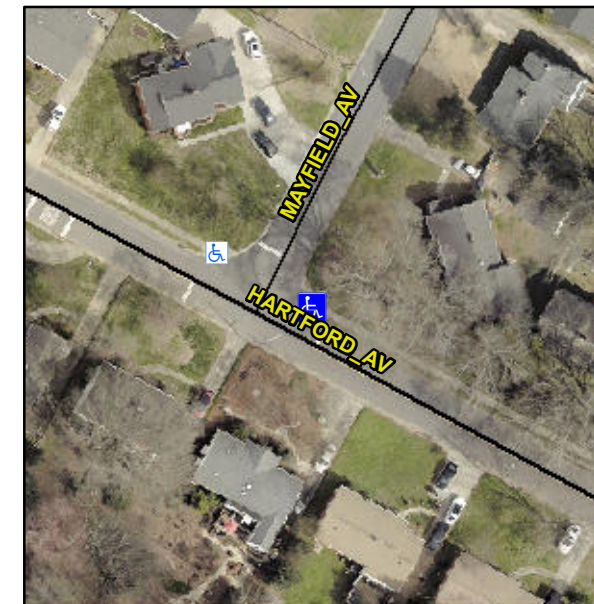
**Not Found, R304.2.1, R304.2.2-Perp, R304.3.2-Para, R304.5.3, R305.2**

| Compliance | Description | Data | Compliance | Description | Data |
|---|---|---|---|---|---|
| N/A | Ramp Length (in) | 59.0 | Yes | Ramp Slope (%) | 6.0 |
| No | Landing Length (in) | N/A | Yes | DWS Provided? | Yes |
| No | Landing Width (in) | N/A | Yes | DWS Contrast? | Yes |
| No | Landing Slope (%) | N/A | Yes | DWS Length (in) | 24.0 |
| No | Landing X Slope (%) | N/A | Yes | DWS Full Width? | Yes |
| N/A | Landing Curb? (Y/N) | No | No | DWS Offset (in) | 4.0 |

**Remove & Replace Curb Ramp With Two New Directional Ramps or Equivalent.**

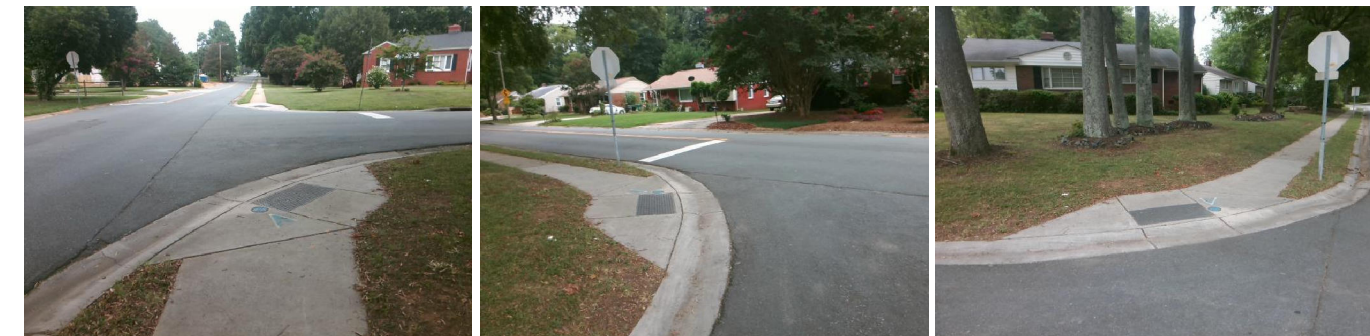
Street 1 Name MAYFIELD AV  
 Stop Condition-Street 2 StopSign  
 Street 2 Name HARTFORD AV  
 Stop Condition-Street 1 StopSign
