Access Compliance Report Public Rights-of-Way (Curb Ramps)

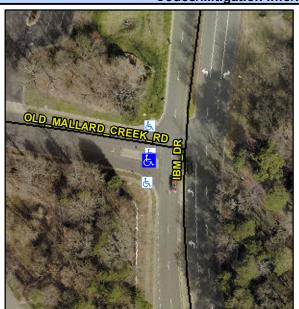
Intersection ID: 5066Main Street: IBM_DRCross Street: OLD_MALLARD_CREEK_RDLocation: WADA ID: 936E3CEA0959Ramp Type: MedianPerpInitial Pass/Fail: Fail Overall Compliance: No Severity Score: 10

Field Measurements/Component Compliance								
Comp	liance Description	Data	Comp	liance Description	Data			
N/A	Ramp Length (in)	52.0	Yes	Ramp Slope (%)	7.0			
No	Ramp Width (in)	40.5	No	Ramp XSlope (%)	2.7			
N/A	Flare Type LT	N/A	N/A	Flare Type RT	N/A			
N/A	Flare Slope LT (%)	N/A	N/A	Flare Slope RT (%)	N/A			
N/A	Flare Traversable LT?	N/A	N/A	Flare Traversable RT?	N/A			
N/A	Landing Length (in)	N/A	N/A	DWS Provided?	N/A			
N/A	Landing Width (in)	N/A	N/A	DWS Contrast?	N/A			
N/A	Landing Slope (%)	N/A	N/A	DWS Length (in)	N/A			
N/A	Landing X Slope (%)	N/A	N/A	DWS Full Width?	N/A			
N/A	Landing Curb? (Y/N)	N/A	N/A	DWS Offset (in)	N/A			
N/A	Shared Landing?	N/A						
N/A	Gutter Ponding?	N/A	N/A	Gutter Slope (%)	N/A			
N/A	Gutter Lip Ht (in)	N/A	N/A	Gutter X Slope (%)	N/A			
N/A	Painted X Walk1?	No	N/A	Painted X Walk2?	N/A			
	X Walk 1 Direction	To S		X Walk 2 Direction	N/A			
N/A	X Walk 1 Width (in)	N/A	N/A	X Walk 2 Width (in)	N/A

X Walk 1 Slope (%)	3.8		X Walk 2 Slope (%)	N/A			
	X Walk 1 X Slope (%)	4.9		X Walk 2 X Slope (%)	N/A			
N/A	Ramp inside XWalk1?	N/A	N/A	Ramp inside XWalk2?	N/A			
	Road Slope (%)	N/A	N/A	Clear Space?	N/A			
	Road X Slope (%)	N/A	N/A	Clear Space to XWalk (in)	N/A			
N/A	Any Obstructions?	N/A	N/A	Storm Grate/Utility Hazard?	N/A			
	Obstruction Type			Storm Grate/Utility Type				
		N/A			N/A			
			Yes	Surface Condition? (G/P)	Good			
D D S	Control of the contro

T CCCIDIC CCIALICIT	
Possible Solutions:	Co
Remove & Replace Entire Ramp.	
	No
	N/
	N/
	N/
	N/
Surveyor Notes:	N/
N/A	N/
	N/
	N/
	N/
PROW/ADA:	N/
Not Found, R304.5.1, R304.5.3	N/
	N/
	N/
	N/
