# Access Compliance Report

## Public Rights-of-Way

### (Curb Ramps)

| Intersection ID: 26464 | Main Street: BEVINGTON_PL | Cross Street: ENCLAVE_PL | Location: NE |

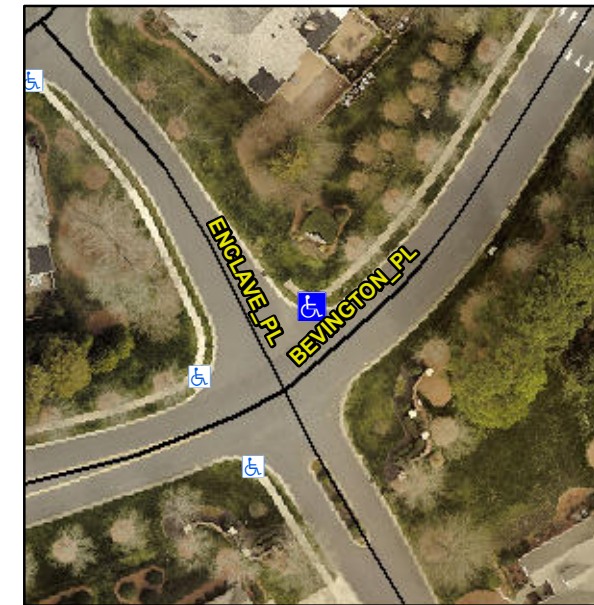
| ADA ID: 93710169160E | Ramp Type: PerpDiag | Initial Pass/Fail: Fail | Overall Compliance: No |

**Not Found, R304.5.3**

| Compliance | Description | Data | Compliance | Description | Data |
|---|---|---|---|---|---|
| Yes | Ramp Width (in) | 48.0 | No | Ramp XSlope (%) | 5.8 |

**Remove & Replace Curb Ramp With Two New Directional Ramps or Equivalent.**

Total Cost: \$ 3200.00
