Access Compliance Report

Public Rights-of-Way

(Curb Ramps)

| Intersection ID: 53289 | Main Street: PROSPERITY RIDGE RD | Cross Street: CRAVEN THOMAS RD | Location: | W |

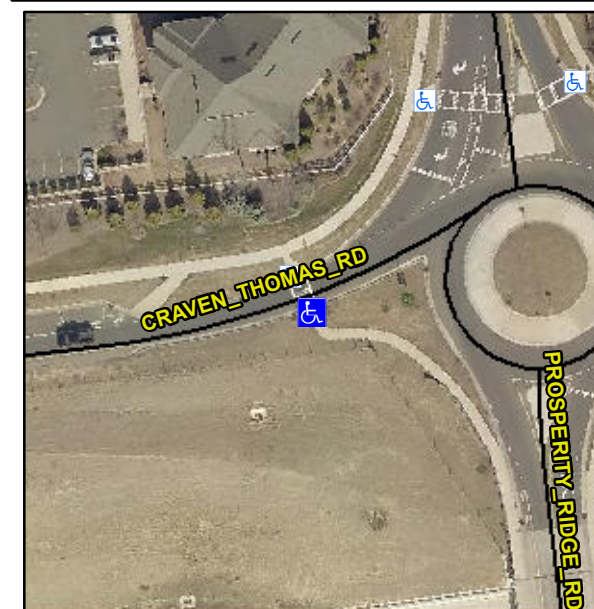
Remove & Replace Detectable Warning System. Gutter Ponding Observed.

| Compliance | Description | Data | Compliance | Description | Data |
|---|---|---|---|---|---|
| N/A | Landing Curb? (Y/N) | No | No | DWS Offset (in) | 5.0 |
| No | Gutter Ponding? | Yes | Yes | Gutter Slope (%) | 2.5 |

Possible Solutions:
