Access Compliance Report

Public Rights-of-Way

(Curb Ramps)

Intersection ID: 11841	Main Street: E_18TH_ST	Cross Street: HARRILL_ST	Location: E
ADA ID: 93776AB481A2	Ramp Type: Directional1	Initial Pass/Fail: Pass	Overall Compliance: No
Severity Score: 0			
Codes/Mitigation Info/Possible Solution		Field Measurements/Component Compliance

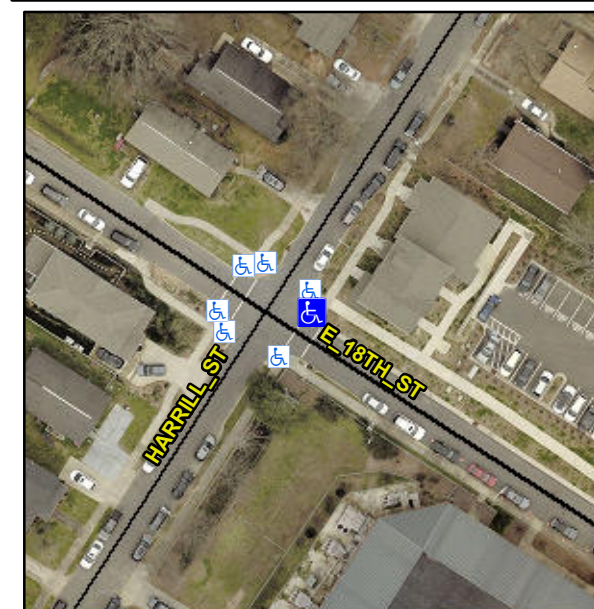
Compliance	Description	Data	Compliance	Description	Data
N/A	Ramp Length (in)	74.0	Yes	Grade Break?	Yes
Yes	Ramp Width (in)	59.0	No	Grade Break Slope (%)	5.9
Yes	Ramp Slope (%)	5.4	Yes	Grade Break XSlope (%)	1.7
Yes	Ramp XSlope (%)	1.6			
Yes	Flare Type LT	N/A	Yes	Flare Type RT	N/A
N/A	Flare Slope LT (%)	N/A	N/A	Flare Slope RT (%)	N/A
N/A	Flare Traversable LT?	No	N/A	Flare Traversable RT?	No
Yes	Landing Length (in)	59.0	Yes	DWS Provided?	Yes
Yes	Landing Width (in)	59.0	Yes	DWS Contrast?	Yes
Yes	Landing Slope (%)	1.2	Yes	DWS Length (in)	24.0
Yes	Landing X Slope (%)	1.9	Yes	DWS Full Width?	Yes
N/A	Landing Curb? (Y/N)	N/A	Yes	DWS Offset LT (in)	1.0
N/A	Shared Landing?	Yes	Yes	DWS Offset RT (in)	22.5
No	Gutter Ponding?	Yes	Yes	Gutter Slope (%)	0.4
Yes	Gutter Lip Ht (in)	0.0	Yes	Gutter X Slope (%)	2.0
N/A	Painted X Walk1?	No		Road Slope (%)	2.0
	X Walk 1 Direction	To SW		Road X Slope (%)	0.4
	X Walk 1 Width (in)	N/A		Clear Space?	Yes

X Walk 1 Slope (%)	2.0	N/A	Clear Space to XWalk (in)	N/A
	X Walk 1 X Slope (%)	0.4	Yes	Storm Grate/Utility Hazard?	No
N/A	Ramp inside XWalk1?	N/A		Storm Grate/Utility Type	
Yes	Any Obstructions?	No			N/A
	Obstruction Type		Yes	Surface Condition? (G/P)	Good
			N/A	Curb Slope (%)	17.8

Possible Solutions:

Remove & Replace Entire Ramp.

Not Found, R304.5.3, R302.7
