# Access Compliance Report

## Public Rights-of-Way

### (Curb Ramps)

Intersection ID: 12358	Main Street: HARRILL_ST	Cross Street: VAN_EVERY_ST	Location: S
ADA ID: 9377A376FC09	Ramp Type: Perp	Initial Pass/Fail: Fail	Overall Compliance: No
		Severity Score: 22.5	
Codes/Mitigation Info/Possible Solution		Field Measurements/Component Compliance

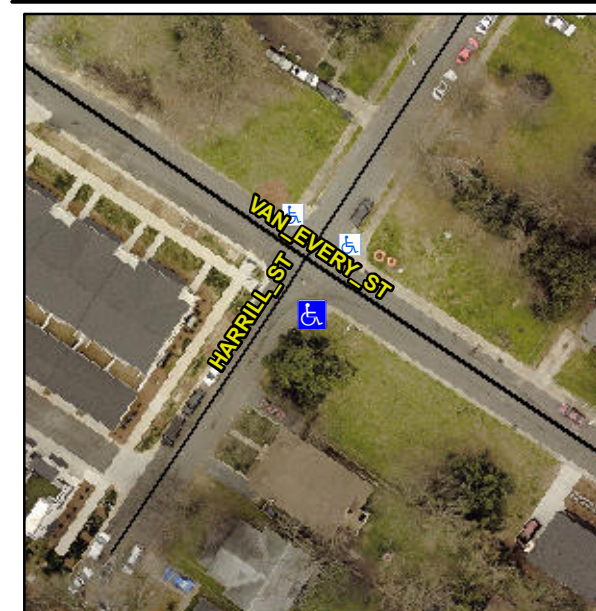
Compliance	Description	Data	Compliance	Description	Data
N/A	Ramp Length (in)	59.0	No	Ramp Slope (%)	10.1
No	Ramp Width (in)	42.0	No	Ramp XSlope (%)	3.0
N/A	Flare Type LT	N/A	N/A	Flare Type RT	N/A
N/A	Flare Slope LT (%)	N/A	N/A	Flare Slope RT (%)	N/A
N/A	Flare Traversable LT?	N/A	N/A	Flare Traversable RT?	N/A
N/A	Landing Length (in)	N/A	N/A	DWS Provided?	N/A
N/A	Landing Width (in)	N/A	N/A	DWS Contrast?	N/A
N/A	Landing Slope (%)	N/A	N/A	DWS Length (in)	N/A
N/A	Landing X Slope (%)	N/A	N/A	DWS Full Width?	N/A
N/A	Landing Curb? (Y/N)	N/A	N/A	DWS Offset (in)	N/A
N/A	Shared Landing?	N/A			
N/A	Gutter Ponding?	N/A	N/A	Gutter Slope (%)	N/A
N/A	Gutter Lip Ht (in)	N/A	N/A	Gutter X Slope (%)	N/A
N/A	Painted X Walk1?	No	N/A	Painted X Walk2?	N/A
	X Walk 1 Direction	To NE		X Walk 2 Direction	N/A
N/A	X Walk 1 Width (in)	N/A	N/A	X Walk 2 Width (in)	N/A
	X Walk 1 Slope (%)	5.0		X Walk 2 Slope (%)	N/A
	X Walk 1 X Slope (%)	1.3		X Walk 2 X Slope (%)	N/A

N/A	Ramp inside XWalk1?	N/A	N/A	Ramp inside XWalk2?	N/A
	Road Slope (%)	1.3	N/A	Clear Space?	N/A
	Road X Slope (%)	5.0	N/A	Clear Space to XWalk (in)	N/A
N/A	Any Obstructions?	N/A	N/A	Storm Grate/Utility Hazard?	N/A
	Obstruction Type			Storm Grate/Utility Type	
		N/A			N/A
			Yes	Surface Condition? (G/P)	Good

**Remove & Replace Entire Ramp.**

**R304.5.1, R304.2.2, R304.5.3**

Total Cost: \$ 1850.00
