Access Compliance Report Public Rights-of-Way (Curb Ramps)

Intersection ID: 43116 Main Street: CENTRAL_AV Cross Street: PECAN_AV Location: NE
ADA ID: 937D5C209583 Ramp Type: Perp Initial Pass/Fail: Fail Overall Compliance: No Severity Score: 12.5

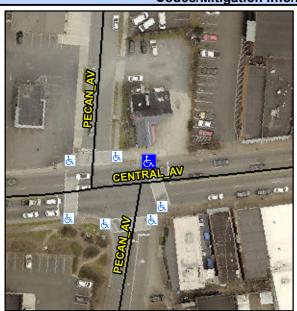
i ossibic odiation			i icia ilicasari	cincints/O	ompo	nent comphanec	
Possible Solutions:		Comp	oliance Description	Data	Comp	oliance Description	Data
Remove & Replace Entire R	amp.	N/A	Ramp Length (in)	65.5	No	Ramp Slope (%)	9.1
·	•	Yes	Ramp Width (in)	50.0	Yes	Ramp XSlope (%)	0.2
		N/A	Flare Type LT	N/A	N/A	Flare Type RT	N/A
		N/A	Flare Slope LT (%)	N/A	N/A	Flare Slope RT (%)	N/A
		N/A	Flare Traversable LT?	N/A	N/A	Flare Traversable RT?	N/A
		N/A	Landing Length (in)	N/A	N/A	DWS Provided?	N/A
Surveyor Notes:		N/A	Landing Width (in)	N/A	N/A	DWS Contrast?	N/A
N/A		N/A	Landing Slope (%)	N/A	N/A	DWS Length (in)	N/A
		N/A	Landing X Slope (%)	N/A	N/A	DWS Full Width?	N/A
		N/A	Landing Curb? (Y/N)	N/A	N/A	DWS Offset (in)	N/A
		N/A	Shared Landing?	N/A			
PROW/ADA:		N/A	Gutter Ponding?	N/A	N/A	Gutter Slope (%)	N/A
Not Found, R304.2.2		N/A	Gutter Lip Ht (in)	N/A	N/A	Gutter X Slope (%)	N/A
		N/A	Painted X Walk1?	Yes	N/A	Painted X Walk2?	N/A
