Access Compliance Report

Public Rights-of-Way (Curb Ramps)

Intersection ID: 15425	Main Street: BERKSHIRE_RD	Cross Street: ELMHURST_RD	Location:	N
ADA ID: 9384285E7543	Ramp Type: PerpDiag	Initial Pass/Fail: Fail	Overall Compliance: No	Severity Score: 67.5
Codes/Mitigation Info/Possible Solution		Field Measurements/Component Compliance

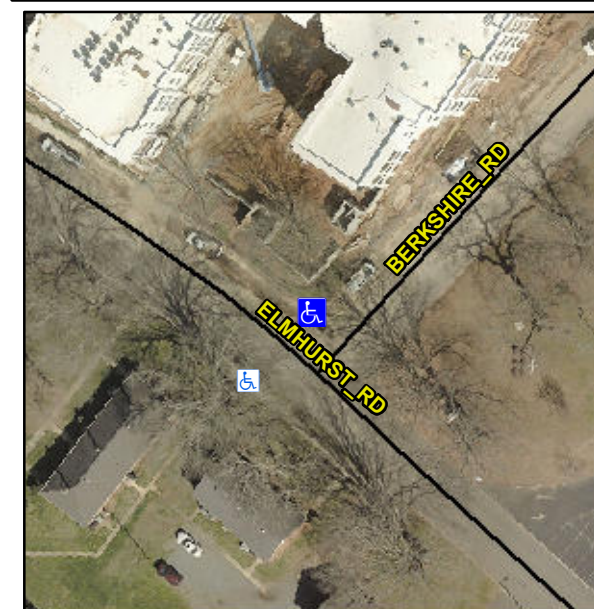
Not Found, R304.5.1, R304.2.2, R304.5.3

Compliance	Description	Data	Compliance	Description	Data
N/A	Ramp Length (in)	61.0	No	Ramp Slope (%)	15.8
No	Ramp Width (in)	34.0	No	Ramp XSlope (%)	8.7
N/A	Flare Type LT	N/A	N/A	Flare Type RT	N/A
N/A	Flare Slope LT (%)	N/A	N/A	Flare Slope RT (%)	N/A
N/A	Flare Traversable LT?	N/A	N/A	Flare Traversable RT?	N/A
N/A	Landing Length (in)	N/A	N/A	DWS Provided?	N/A
N/A	Landing Width (in)	N/A	N/A	DWS Contrast?	N/A
N/A	Landing Slope (%)	N/A	N/A	DWS Length (in)	N/A
N/A	Landing X Slope (%)	N/A	N/A	DWS Full Width?	N/A
N/A	Landing Curb? (Y/N)	N/A	N/A	DWS Offset (in)	N/A
N/A	Shared Landing?	N/A			
N/A	Gutter Ponding?	N/A	N/A	Gutter Slope (%)	N/A
N/A	Gutter Lip Ht (in)	N/A	N/A	Gutter X Slope (%)	N/A
N/A	Painted X Walk1?	No	N/A	Painted X Walk2?	No
	X Walk 1 Direction	To SW		X Walk 2 Direction	To SE
N/A	X Walk 1 Width (in)	N/A	N/A	X Walk 2 Width (in)	N/A
	X Walk 1 Slope (%)	2.0		X Walk 2 Slope (%)	3.2
	X Walk 1 X Slope (%)	1.9		X Walk 2 X Slope (%)	1.1

N/A	Ramp inside XWalk1?	N/A	N/A	Ramp inside XWalk2?	N/A
	Road Slope (%)	2.3	N/A	Clear Space?	N/A
	Road X Slope (%)	3.0	N/A	Clear Space to XWalk (in)	N/A
N/A	Any Obstructions?	N/A	N/A	Storm Grate/Utility Hazard?	N/A
	Obstruction Type			Storm Grate/Utility Type	
		N/A			N/A
			Yes	Surface Condition? (G/P)	Good

Possible Solutions:

Remove & Replace Curb Ramp With Two New Directional Ramps or Equivalent.
