Access Compliance Report

Public Rights-of-Way

(Curb Ramps)

Intersection ID: 11867	Main Street: E_17TH_ST	Cross Street: SEIGLE_AV	Location: E
ADA ID: 938A907951F0	Ramp Type: Perp	Initial Pass/Fail: Fail	Overall Compliance: No
Severity Score: 22.5			
Codes/Mitigation Info/Possible Solution		Field Measurements/Component Compliance

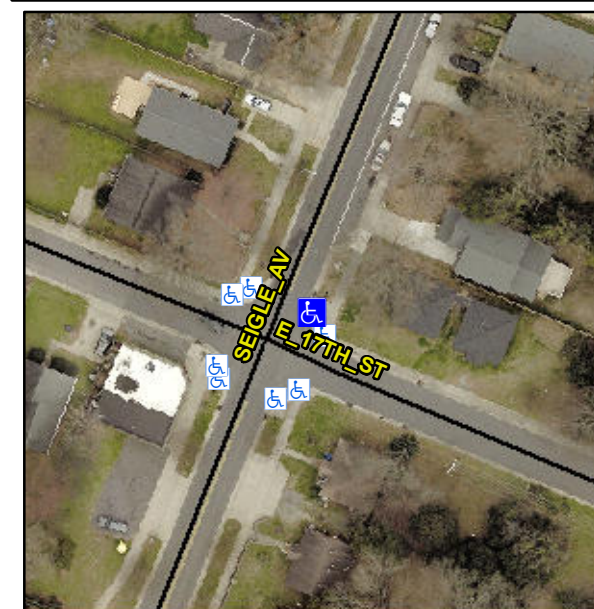
Not Found, R304.5.1, R304.2.2

Compliance	Description	Data	Compliance	Description	Data
N/A	Ramp Length (in)	65.0	No	Ramp Slope (%)	8.9
No	Ramp Width (in)	47.0	Yes	Ramp XSlope (%)	4.3
N/A	Flare Type LT	N/A	N/A	Flare Type RT	N/A
N/A	Flare Slope LT (%)	N/A	N/A	Flare Slope RT (%)	N/A
N/A	Flare Traversable LT?	N/A	N/A	Flare Traversable RT?	N/A
N/A	Landing Length (in)	N/A	N/A	DWS Provided?	N/A
N/A	Landing Width (in)	N/A	N/A	DWS Contrast?	N/A
N/A	Landing Slope (%)	N/A	N/A	DWS Length (in)	N/A
N/A	Landing X Slope (%)	N/A	N/A	DWS Full Width?	N/A
N/A	Landing Curb? (Y/N)	N/A	N/A	DWS Offset (in)	N/A
N/A	Shared Landing?	N/A			
N/A	Gutter Ponding?	N/A	N/A	Gutter Slope (%)	N/A
N/A	Gutter Lip Ht (in)	N/A	N/A	Gutter X Slope (%)	N/A
N/A	Painted X Walk1?	No	N/A	Painted X Walk2?	N/A
	X Walk 1 Direction	To NW		X Walk 2 Direction	N/A
N/A	X Walk 1 Width (in)	N/A	N/A	X Walk 2 Width (in)	N/A
	X Walk 1 Slope (%)	1.2		X Walk 2 Slope (%)	N/A
	X Walk 1 X Slope (%)	7.3		X Walk 2 X Slope (%)	N/A

N/A	Ramp inside XWalk1?	N/A	N/A	Ramp inside XWalk2?	N/A
	Road Slope (%)	N/A	N/A	Clear Space?	N/A
	Road X Slope (%)	N/A	N/A	Clear Space to XWalk (in)	N/A
N/A	Any Obstructions?	N/A	N/A	Storm Grate/Utility Hazard?	N/A
	Obstruction Type			Storm Grate/Utility Type	
		N/A			N/A
			Yes	Surface Condition? (G/P)	Good

Possible Solutions:

Remove & Replace Entire Ramp.
