Access Compliance Report

Public Rights-of-Way

(Curb Ramps)

Intersection ID: 18700	Main Street: PELHAM_LN	Cross Street: SHARON_LN	Location: SE
ADA ID: 938C01E1CDEB	Ramp Type: PerpDiag	Initial Pass/Fail: Fail	Overall Compliance: No
		Severity Score: 8.75

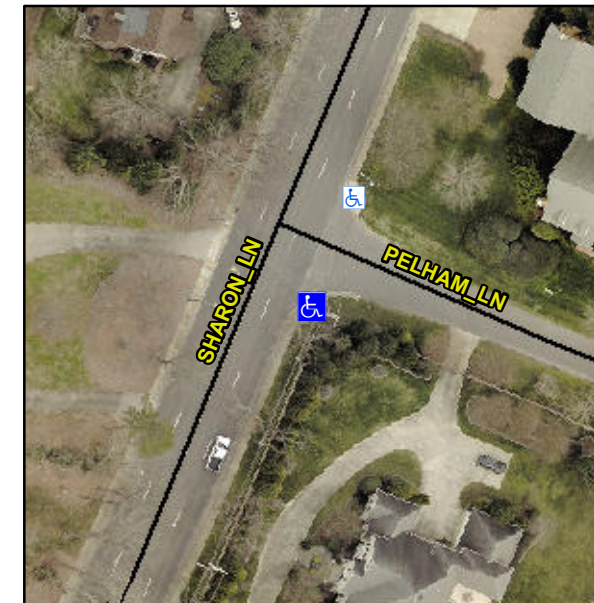
Not Found, R304.5.1

Compliance	Description	Data	Compliance	Description	Data
N/A	Ramp Length (in)	100.5	Yes	Ramp Slope (%)	7.5
No	Ramp Width (in)	47.0	Yes	Ramp XSlope (%)	0.7
N/A	Flare Type LT	N/A	N/A	Flare Type RT	N/A
N/A	Flare Slope LT (%)	N/A	N/A	Flare Slope RT (%)	N/A
N/A	Flare Traversable LT?	N/A	N/A	Flare Traversable RT?	N/A
N/A	Landing Length (in)	N/A	N/A	DWS Provided?	N/A
N/A	Landing Width (in)	N/A	N/A	DWS Contrast?	N/A
N/A	Landing Slope (%)	N/A	N/A	DWS Length (in)	N/A
N/A	Landing X Slope (%)	N/A	N/A	DWS Full Width?	N/A
N/A	Landing Curb? (Y/N)	N/A	N/A	DWS Offset (in)	N/A
N/A	Shared Landing?	N/A			
N/A	Gutter Ponding?	N/A	N/A	Gutter Slope (%)	N/A
N/A	Gutter Lip Ht (in)	N/A	N/A	Gutter X Slope (%)	N/A
N/A	Painted X Walk1?	No	N/A	Painted X Walk2?	No
	X Walk 1 Direction	To NE		X Walk 2 Direction	To NW
N/A	X Walk 1 Width (in)	N/A	N/A	X Walk 2 Width (in)	N/A
	X Walk 1 Slope (%)	3.5		X Walk 2 Slope (%)	4.1
	X Walk 1 X Slope (%)	1.6		X Walk 2 X Slope (%)	3.9

N/A	Ramp inside XWalk1?	N/A	N/A	Ramp inside XWalk2?	N/A
	Road Slope (%)	0.6	N/A	Clear Space?	N/A
	Road X Slope (%)	7.0	N/A	Clear Space to XWalk (in)	N/A
N/A	Any Obstructions?	N/A	N/A	Storm Grate/Utility Hazard?	N/A
	Obstruction Type			Storm Grate/Utility Type	
		N/A			N/A
			Yes	Surface Condition? (G/P)	Good

Remove & Replace Curb Ramp With Two New Directional Ramps or Equivalent.
