# Access Compliance Report

## Public Rights-of-Way

| Intersection ID: 7036 | Main Street: BEATTIES_FORD_RD | Cross Street: MCALLISTER_DR | Location: NE |
| ADA ID: 9395DE66620C | Ramp Type: Combination1 | Initial Pass/Fail: Fail | Overall Compliance: No |

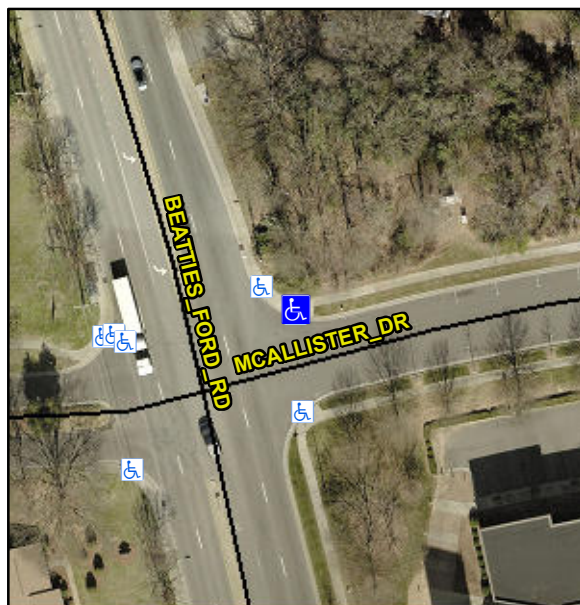
**RP & RT RP < 5%**

**R304.5.3, R304.3.2**

| Compliance | Description | Data | Compliance | Description | Data |
|---|---|---|---|---|---|
| No | Ramp Slope LT (%) | 11.3 | Yes | Ramp Slope RT (%) | 0.3 |
| No | Ramp XSlope LT (%) | 9.3 | No | Ramp XSlope RT (%) | 2.3 |
| Yes | Ramp Width (in) | 48.0 | No | Ramp XSlope (%) | 2.8 |

**Remove & Replace Entire Ramp.**
