# Access Compliance Report

## Public Rights-of-Way

### (Curb Ramps)

Intersection ID: 14356	Main Street: BAXTER_ST	Cross Street: S_TORRENCE_ST	Location: N
ADA ID: 939CF533EF5F	Ramp Type: BlendTrans2	Initial Pass/Fail: Fail	Overall Compliance: No
			Severity Score: 21.25

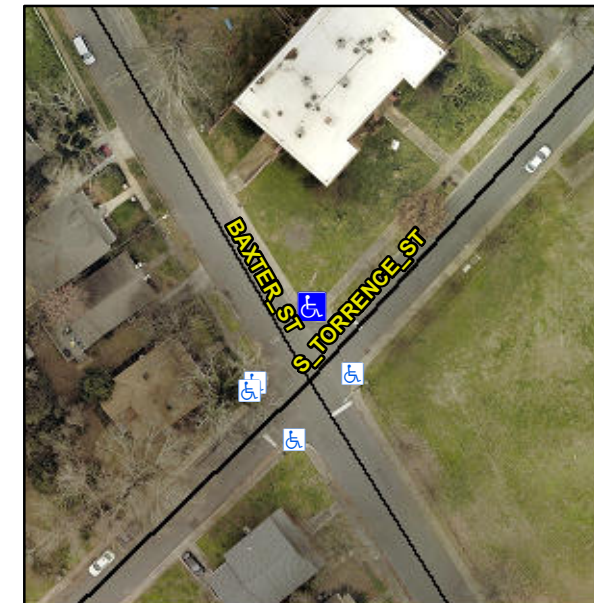
**Not Found, R304.5.1, R304.5.3**

Compliance	Description	Data	Compliance	Description	Data
N/A	Ramp Length (in)	70.0	Yes	BlendTrans Slope (%)	4.5
No	Ramp Width (in)	45.0	No	BlendTrans XSlope (%)	5.2
N/A	Flare Type LT	N/A	N/A	Flare Type RT	N/A
N/A	Flare Slope LT (%)	N/A	N/A	Flare Slope RT (%)	N/A
N/A	Flare Traversable LT?	N/A	N/A	Flare Traversable RT?	N/A
N/A	Landing Length (in)	N/A	N/A	DWS Provided?	N/A
N/A	Landing Width (in)	N/A	N/A	DWS Contrast?	N/A
N/A	Landing Slope (%)	N/A	N/A	DWS Length (in)	N/A
N/A	Landing X Slope (%)	N/A	N/A	DWS Full Width?	N/A
N/A	Landing Curb? (Y/N)	N/A	N/A	DWS Offset (in)	N/A
N/A	Shared Landing?	N/A			
N/A	Gutter Ponding?	N/A	N/A	Gutter Slope (%)	N/A
N/A	Gutter Lip Ht (in)	N/A	N/A	Gutter X Slope (%)	N/A
N/A	Painted X Walk1?	No	N/A	Painted X Walk2?	No
	X Walk 1 Direction	To SW		X Walk 2 Direction	To SE
	X Walk 1 Width (in)	N/A		X Walk 2 Width (in)	N/A
	X Walk 1 Slope (%)	2.3		X Walk 2 Slope (%)	5.2
	X Walk 1 X Slope (%)	2.6		X Walk 2 X Slope (%)	3.2

N/A	Ramp inside XWalk1?	N/A	N/A	Ramp inside XWalk2?	N/A
	Road Slope (%)	4.3		Clear Space?	N/A
	Road X Slope (%)	2.6	N/A	Clear Space to XWalk (in)	N/A
N/A	Any Obstructions?	N/A	N/A	Storm Grate/Utility Hazard?	N/A
	Obstruction Type			Storm Grate/Utility Type	
		N/A			N/A
			Yes	Surface Condition? (G/P)	Good
			No	Curb Slope (%)	18.5

**Remove & Replace Curb Ramp With Two New Directional Ramps or Equivalent.**
