Access Compliance Report

Public Rights-of-Way

(Curb Ramps)

Intersection ID: 44063	Main Street: SEDGEMOOR_LN	Cross Street: GRAYWELL_LN	Location:	N
ADA ID: 93A8E6E9C2A2	Ramp Type: BlendTrans1	Initial Pass/Fail: Fail	Overall Compliance: No	Severity Score: 42.5

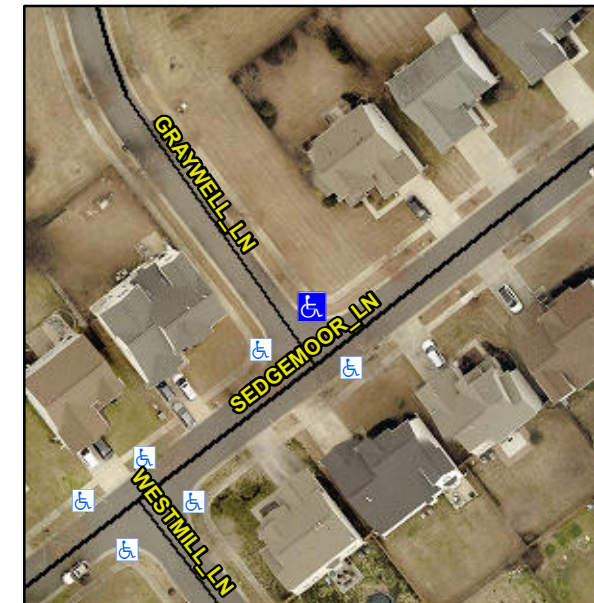
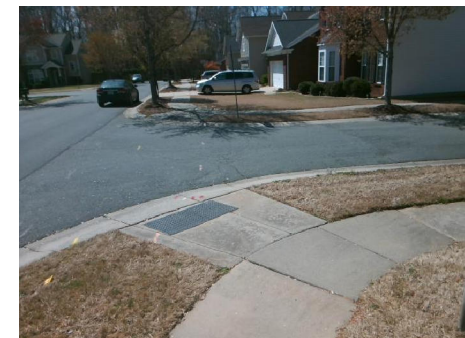
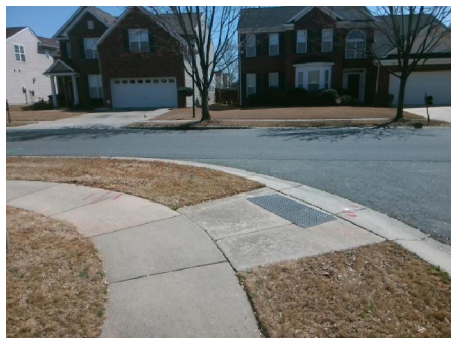
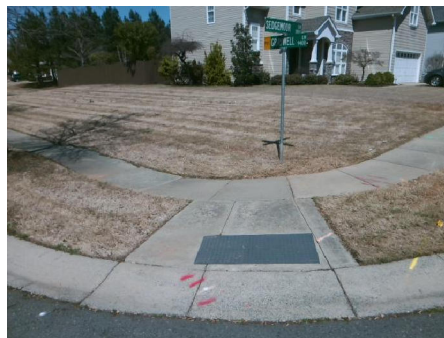
R304.5.1, R304.5.3

Compliance	Description	Data	Compliance	Description	Data
N/A	Ramp Length (in)	71.5	Yes	BlendTrans Slope (%)	3.0
No	Ramp Width (in)	33.5	No	BlendTrans XSlope (%)	7.5
N/A	Flare Type LT	N/A	N/A	Flare Type RT	N/A
N/A	Flare Slope LT (%)	N/A	N/A	Flare Slope RT (%)	N/A
N/A	Flare Traversable LT?	N/A	N/A	Flare Traversable RT?	N/A
N/A	Landing Length (in)	N/A	N/A	DWS Provided?	N/A
N/A	Landing Width (in)	N/A	N/A	DWS Contrast?	N/A
N/A	Landing Slope (%)	N/A	N/A	DWS Length (in)	N/A
N/A	Landing X Slope (%)	N/A	N/A	DWS Full Width?	N/A
N/A	Landing Curb? (Y/N)	N/A	N/A	DWS Offset (in)	N/A
N/A	Shared Landing?	N/A			
N/A	Gutter Ponding?	N/A	N/A	Gutter Slope (%)	N/A
N/A	Gutter Lip Ht (in)	N/A	N/A	Gutter X Slope (%)	N/A
N/A	Painted X Walk1?	No	N/A	Painted X Walk2?	No
	X Walk 1 Direction	To SW		X Walk 2 Direction	To SE
	X Walk 1 Width (in)	N/A		X Walk 2 Width (in)	N/A
	X Walk 1 Slope (%)	2.1		X Walk 2 Slope (%)	4.4
	X Walk 1 X Slope (%)	4.9		X Walk 2 X Slope (%)	2.8

N/A	Ramp inside XWalk1?	N/A	N/A	Ramp inside XWalk2?	N/A
	Road Slope (%)	5.5		Clear Space?	N/A
	Road X Slope (%)	2.5	N/A	Clear Space to XWalk (in)	N/A
N/A	Any Obstructions?	N/A	N/A	Storm Grate/Utility Hazard?	N/A
	Obstruction Type			Storm Grate/Utility Type	
		N/A			N/A
			Yes	Surface Condition? (G/P)	Good
			N/A	Curb Slope (%)	2.7

Remove & Replace Curb Ramp With Two New Directional Ramps or Equivalent.
