# Access Compliance Report

## Public Rights-of-Way

### (Curb Ramps)

Intersection ID: 11256	Main Street: N_IRWIN_AV	Cross Street: W_5TH_ST	Location: N
ADA ID: 93A93E7625B6	Ramp Type: BlendTrans1	Initial Pass/Fail: Fail	Overall Compliance: No
		Severity Score: 12.5

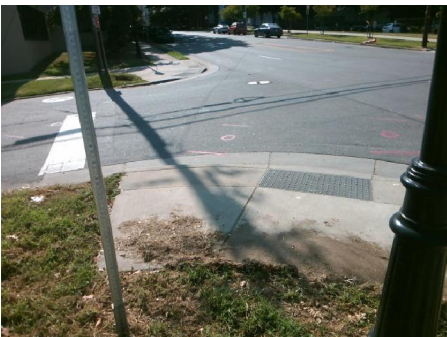
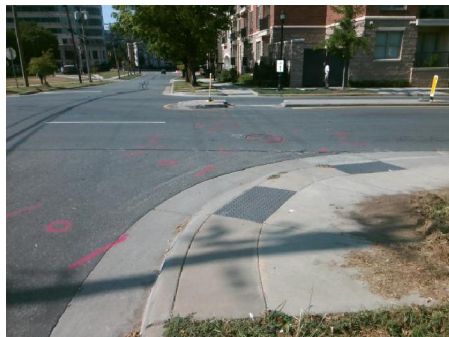
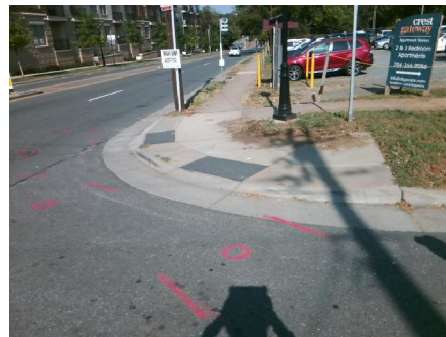
**NO LNDG**

**Not Found, R304.5.3**

Compliance	Description	Data	Compliance	Description	Data
N/A	Ramp Length (in)	85.0	Yes	BlendTrans Slope (%)	4.0
Yes	Ramp Width (in)	49.0	No	BlendTrans XSlope (%)	5.5
N/A	Flare Type LT	N/A	N/A	Flare Type RT	N/A
N/A	Flare Slope LT (%)	N/A	N/A	Flare Slope RT (%)	N/A
N/A	Flare Traversable LT?	N/A	N/A	Flare Traversable RT?	N/A
N/A	Landing Length (in)	N/A	N/A	DWS Provided?	N/A
N/A	Landing Width (in)	N/A	N/A	DWS Contrast?	N/A
N/A	Landing Slope (%)	N/A	N/A	DWS Length (in)	N/A
N/A	Landing X Slope (%)	N/A	N/A	DWS Full Width?	N/A
N/A	Landing Curb? (Y/N)	N/A	N/A	DWS Offset (in)	N/A
N/A	Shared Landing?	N/A			
N/A	Gutter Ponding?	N/A	N/A	Gutter Slope (%)	N/A
N/A	Gutter Lip Ht (in)	N/A	N/A	Gutter X Slope (%)	N/A
N/A	Painted X Walk1?	No	N/A	Painted X Walk2?	N/A
	X Walk 1 Direction	To SE		X Walk 2 Direction	N/A
	X Walk 1 Width (in)	N/A		X Walk 2 Width (in)	N/A
	X Walk 1 Slope (%)	5.7		X Walk 2 Slope (%)	N/A
	X Walk 1 X Slope (%)	0.1		X Walk 2 X Slope (%)	N/A

N/A	Ramp inside XWalk1?	N/A	N/A	Ramp inside XWalk2?	N/A
	Road Slope (%)	0.1		Clear Space?	N/A
	Road X Slope (%)	5.7	N/A	Clear Space to XWalk (in)	N/A
N/A	Any Obstructions?	N/A	N/A	Storm Grate/Utility Hazard?	N/A
	Obstruction Type			Storm Grate/Utility Type	
		N/A			N/A
			Yes	Surface Condition? (G/P)	Good
			No	Curb Slope (%)	12.6

**Remove & Replace Curb Ramp With Two New Directional Ramps or Equivalent.**
