Access Compliance Report Public Rights-of-Way (Curb Ramps)

Intersection ID: 27228 Main St	27228 Main Street: BALLANTYNE_COMMONS_PY Cross Street: TOM_SHORT_RD						SW
		Initial Pass		Location: o Severity Score:	22.5

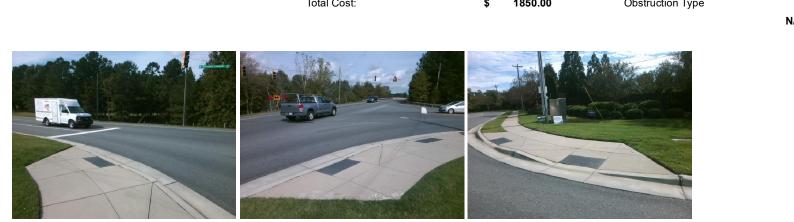
22.5		
Codes/Mitigation Info/Possible Solution		Field Measurements/Component Compliance					
The Maria La State /	Possible Solutions:	Co	npliance Desc	ription Data	Comp	liance Description	Data
	Remove & Replace Entire Ramp.	N/A	1 0	()	No	Ramp Slope (%)	9.3
		No	Ramp Width	n (in) 47.0	No	Ramp XSlope (%)	3.3
A CONTRACTOR OF		N/A	Flare Type I	LT N/A	N/A	Flare Type RT	N/A
TOTES A		N/A	Flare Slope	LT (%) N/A	N/A	Flare Slope RT (%)	N/A
and an the section of		N/A	Flare Traver	rsable LT? N/A	N/A	Flare Traversable RT?	N/A
