Access Compliance Report Public Rights-of-Way (Curb Ramps)

Intersection ID: N/A Main Street: BALLANTYNE VILLAGE DR Cross Street: WAXBERRY DR Location: S **Overall Compliance: No Severity Score:** 12.5 ADA ID: 93BD91353B16 Ramp Type: PerpDiag Initial Pass/Fail: Fail

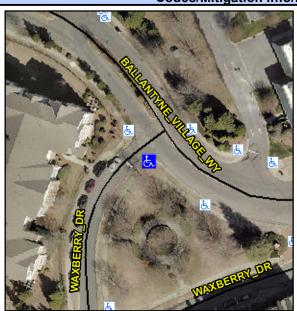
X Walk 2 X Slope (%) X Walk 1 X Slope (%) N/A Ramp inside XWalk1? N/A N/A Ramp inside XWalk2? N/A Road Slope (%) 1.3 N/A Clear Space? N/A N/A Road X Slope (%) 2.0 Clear Space to XWalk (in) N/A Any Obstructions? N/A N/A N/A Storm Grate/Utility Hazard? N/A **Obstruction Type** Storm Grate/Utility Type N/A N/A Yes Surface Condition? (G/P) Good

Street 1 Name Stop Condition-Street 2 Street 2 Name Stop Condition-Street 1 **BALLANTYNE VILLAGE WY** None **WAXBERRY DR** StopSign Possible Solutions: Remove & Replace Curb Ramp With Two New Directional Ramps or Equivalent. Surve N/A PROV Not

Surveyor Notes:		N/A
N/A		N/A
		N/A
		N/A
		N/A
PROW/ADA:		N/A
Not Found, R304.5.3		N/A
		N/A
		N/A
		N/A
Total Cost:	\$ 3200.00	N/A
