# Access Compliance Report

## Public Rights-of-Way

### (Curb Ramps)

Intersection ID: 15045	Main Street: FAIRWOOD_AV	Cross Street: S_TRYON_ST	Location:	N
ADA ID: 93E25CBD41CC	Ramp Type: PerpDiag	Initial Pass/Fail: Fail	Overall Compliance: No	Severity Score: 37.5
Codes/Mitigation Info/Possible Solution		Field Measurements/Component Compliance

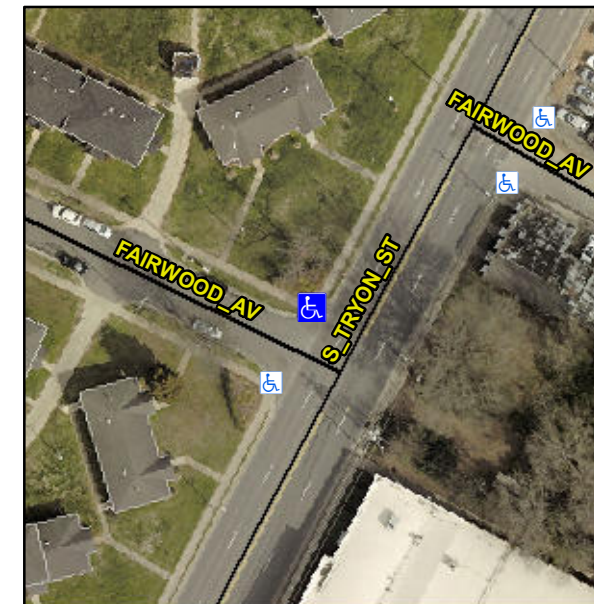
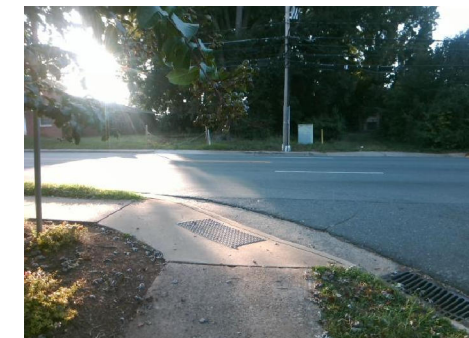
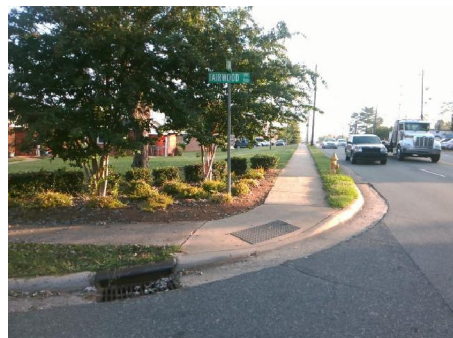
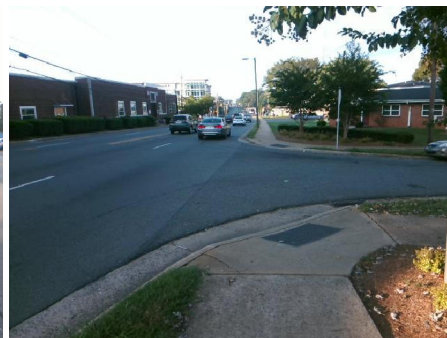
**Not Found, R304.2.2, R304.5.3**

Compliance	Description	Data	Compliance	Description	Data
N/A	Ramp Length (in)	58.0	No	Ramp Slope (%)	8.8
Yes	Ramp Width (in)	48.0	No	Ramp XSlope (%)	9.2
N/A	Flare Type LT	N/A	N/A	Flare Type RT	N/A
N/A	Flare Slope LT (%)	N/A	N/A	Flare Slope RT (%)	N/A
N/A	Flare Traversable LT?	N/A	N/A	Flare Traversable RT?	N/A
N/A	Landing Length (in)	N/A	N/A	DWS Provided?	N/A
N/A	Landing Width (in)	N/A	N/A	DWS Contrast?	N/A
N/A	Landing Slope (%)	N/A	N/A	DWS Length (in)	N/A
N/A	Landing X Slope (%)	N/A	N/A	DWS Full Width?	N/A
N/A	Landing Curb? (Y/N)	N/A	N/A	DWS Offset (in)	N/A
N/A	Shared Landing?	N/A			
N/A	Gutter Ponding?	N/A	N/A	Gutter Slope (%)	N/A
N/A	Gutter Lip Ht (in)	N/A	N/A	Gutter X Slope (%)	N/A
N/A	Painted X Walk1?	No	N/A	Painted X Walk2?	No
	X Walk 1 Direction	To SW		X Walk 2 Direction	To SE
N/A	X Walk 1 Width (in)	N/A	N/A	X Walk 2 Width (in)	N/A
	X Walk 1 Slope (%)	1.3		X Walk 2 Slope (%)	3.4
	X Walk 1 X Slope (%)	6.0		X Walk 2 X Slope (%)	2.6

N/A	Ramp inside XWalk1?	N/A	N/A	Ramp inside XWalk2?	N/A
	Road Slope (%)	6.0	N/A	Clear Space?	N/A
	Road X Slope (%)	2.5	N/A	Clear Space to XWalk (in)	N/A
N/A	Any Obstructions?	N/A	N/A	Storm Grate/Utility Hazard?	N/A
	Obstruction Type			Storm Grate/Utility Type	
		N/A			N/A
		Yes		Surface Condition? (G/P)	Good

**Remove & Replace Curb Ramp With Two New Directional Ramps or Equivalent.**

Total Cost: \$ 3200.00
