Access Compliance Report

Public Rights-of-Way

(Curb Ramps)

Intersection ID: 3033	Main Street: DEARMON_RD	Cross Street: BENFIELD_RD	Location:	E
ADA ID: 93E280D30FCF	Ramp Type: Perp	Initial Pass/Fail: Fail	Overall Compliance: No	Severity Score: 26.25

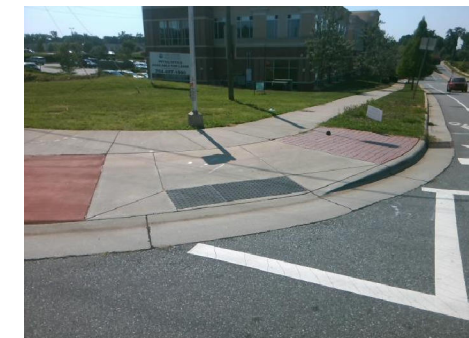
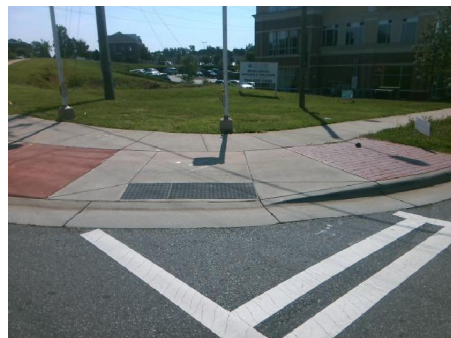
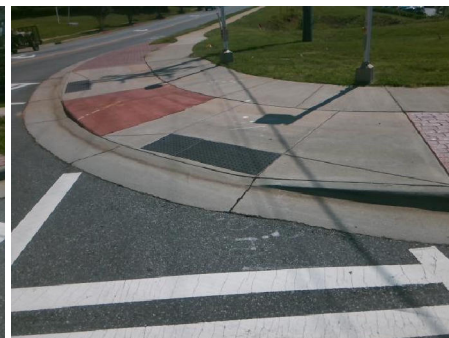
Compliance	Description	Data	Compliance	Description	Data
N/A	Ramp Length (in)	96.0	No	Ramp Slope (%)	19.3
Yes	Ramp Width (in)	66.5	Yes	Ramp XSlope (%)	4.7
N/A	Flare Type LT	N/A	N/A	Flare Type RT	N/A
N/A	Flare Slope LT (%)	N/A	N/A	Flare Slope RT (%)	N/A
N/A	Flare Traversable LT?	N/A	N/A	Flare Traversable RT?	N/A
N/A	Landing Length (in)	N/A	N/A	DWS Provided?	N/A
N/A	Landing Width (in)	N/A	N/A	DWS Contrast?	N/A
N/A	Landing Slope (%)	N/A	N/A	DWS Length (in)	N/A
N/A	Landing X Slope (%)	N/A	N/A	DWS Full Width?	N/A
N/A	Landing Curb? (Y/N)	N/A	N/A	DWS Offset (in)	N/A
N/A	Shared Landing?	N/A			
N/A	Gutter Ponding?	N/A	N/A	Gutter Slope (%)	N/A
N/A	Gutter Lip Ht (in)	N/A	N/A	Gutter X Slope (%)	N/A
N/A	Painted X Walk1?	Yes	N/A	Painted X Walk2?	N/A
	X Walk 1 Direction	To SW		X Walk 2 Direction	N/A
N/A	X Walk 1 Width (in)	111.0	N/A	X Walk 2 Width (in)	N/A
	X Walk 1 Slope (%)	5.2		X Walk 2 Slope (%)	N/A
	X Walk 1 X Slope (%)	5.6		X Walk 2 X Slope (%)	N/A

N/A	Ramp inside XWalk1?	Yes	N/A	Ramp inside XWalk2?	N/A
	Road Slope (%)	N/A	N/A	Clear Space?	N/A
	Road X Slope (%)	N/A	N/A	Clear Space to XWalk (in)	N/A
N/A	Any Obstructions?	N/A	N/A	Storm Grate/Utility Hazard?	N/A
	Obstruction Type			Storm Grate/Utility Type	
		N/A			N/A
		Yes		Surface Condition? (G/P)	Good

Remove & Replace Entire Ramp.

R304.2.2
