# Access Compliance Report

## Public Rights-of-Way

### (Curb Ramps)

Intersection ID: 16419	Main Street: LANTANA_AV	Cross Street: N SHARON AMITY RD	Location: E
ADA ID: 93EC42C824AC	Ramp Type: PerpDiag	Initial Pass/Fail: Fail	Overall Compliance: No
			Severity Score: 31.25

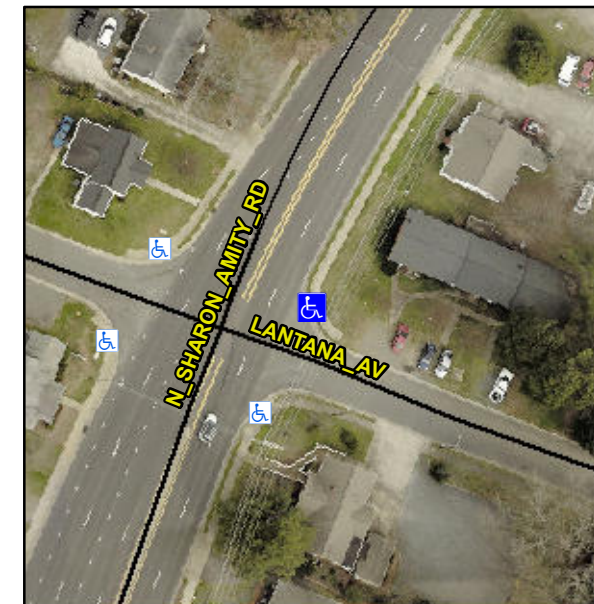
**Not Found, R304.5.1, R304.2.2, R304.5.3**

Compliance	Description	Data	Compliance	Description	Data
N/A	Ramp Length (in)	83.0	No	Ramp Slope (%)	9.1
No	Ramp Width (in)	34.0	No	Ramp XSlope (%)	4.6
N/A	Flare Type LT	N/A	N/A	Flare Type RT	N/A
N/A	Flare Slope LT (%)	N/A	N/A	Flare Slope RT (%)	N/A
N/A	Flare Traversable LT?	N/A	N/A	Flare Traversable RT?	N/A
N/A	Landing Length (in)	N/A	N/A	DWS Provided?	N/A
N/A	Landing Width (in)	N/A	N/A	DWS Contrast?	N/A
N/A	Landing Slope (%)	N/A	N/A	DWS Length (in)	N/A
N/A	Landing X Slope (%)	N/A	N/A	DWS Full Width?	N/A
N/A	Landing Curb? (Y/N)	N/A	N/A	DWS Offset (in)	N/A
N/A	Shared Landing?	N/A			
N/A	Gutter Ponding?	N/A	N/A	Gutter Slope (%)	N/A
N/A	Gutter Lip Ht (in)	N/A	N/A	Gutter X Slope (%)	N/A
N/A	Painted X Walk1?	No	N/A	Painted X Walk2?	No
	X Walk 1 Direction	To NW		X Walk 2 Direction	To SW
N/A	X Walk 1 Width (in)	N/A	N/A	X Walk 2 Width (in)	N/A
	X Walk 1 Slope (%)	5.4		X Walk 2 Slope (%)	0.8
	X Walk 1 X Slope (%)	1.4		X Walk 2 X Slope (%)	6.5

N/A	Ramp inside XWalk1?	N/A	N/A	Ramp inside XWalk2?	N/A
	Road Slope (%)	4.1	N/A	Clear Space?	N/A
	Road X Slope (%)	3.2	N/A	Clear Space to XWalk (in)	N/A
N/A	Any Obstructions?	N/A	N/A	Storm Grate/Utility Hazard?	N/A
	Obstruction Type			Storm Grate/Utility Type	
		N/A			N/A
			Yes	Surface Condition? (G/P)	Good

**Remove & Replace Curb Ramp With Two New Directional Ramps or Equivalent.**
