Access Compliance Report

Public Rights-of-Way

(Curb Ramps)

Intersection ID: 49274	Main Street: ROTHE_HOUSE_RD	Cross Street: REMINISCE_LN	Location: S
ADA ID: 93F1ACE49624	Ramp Type: PerpDiag	Initial Pass/Fail: Fail	Overall Compliance: No
		Severity Score: 35

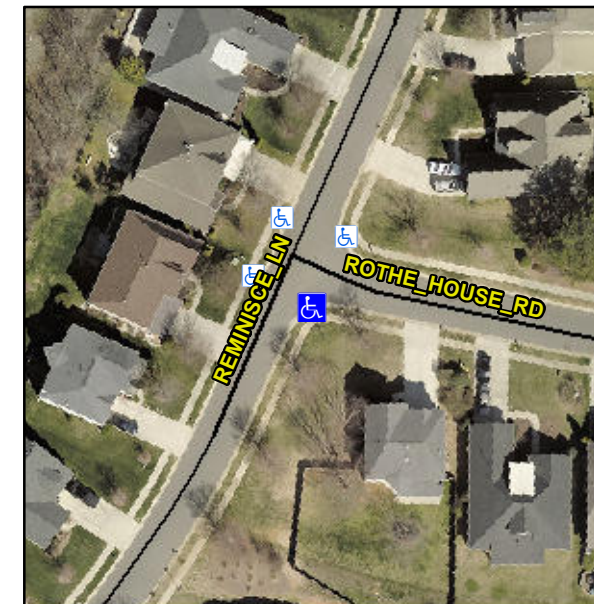
Not Found, R304.5.1, R304.2.2, R304.5.3

Compliance	Description	Data	Compliance	Description	Data
N/A	Ramp Length (in)	46.5	No	Ramp Slope (%)	13.2
No	Ramp Width (in)	47.3	No	Ramp XSlope (%)	2.9
N/A	Flare Type LT	N/A	N/A	Flare Type RT	N/A
N/A	Flare Slope LT (%)	N/A	N/A	Flare Slope RT (%)	N/A
N/A	Flare Traversable LT?	N/A	N/A	Flare Traversable RT?	N/A
N/A	Landing Length (in)	N/A	N/A	DWS Provided?	N/A
N/A	Landing Width (in)	N/A	N/A	DWS Contrast?	N/A
N/A	Landing Slope (%)	N/A	N/A	DWS Length (in)	N/A
N/A	Landing X Slope (%)	N/A	N/A	DWS Full Width?	N/A
N/A	Landing Curb? (Y/N)	N/A	N/A	DWS Offset (in)	N/A
N/A	Shared Landing?	N/A			
N/A	Gutter Ponding?	N/A	N/A	Gutter Slope (%)	N/A
N/A	Gutter Lip Ht (in)	N/A	N/A	Gutter X Slope (%)	N/A
N/A	Painted X Walk1?	No	N/A	Painted X Walk2?	No
	X Walk 1 Direction	To NE		X Walk 2 Direction	To NW
N/A	X Walk 1 Width (in)	N/A	N/A	X Walk 2 Width (in)	N/A
	X Walk 1 Slope (%)	5.8		X Walk 2 Slope (%)	5.9
	X Walk 1 X Slope (%)	3.1		X Walk 2 X Slope (%)	1.2

N/A	Ramp inside XWalk1?	N/A	N/A	Ramp inside XWalk2?	N/A
	Road Slope (%)	1.3	N/A	Clear Space?	N/A
	Road X Slope (%)	4.2	N/A	Clear Space to XWalk (in)	N/A
N/A	Any Obstructions?	N/A	N/A	Storm Grate/Utility Hazard?	N/A
	Obstruction Type			Storm Grate/Utility Type	
		N/A			N/A
			Yes	Surface Condition? (G/P)	Good

Remove & Replace Curb Ramp With Two New Directional Ramps or Equivalent.
