Access Compliance Report

Public Rights-of-Way

(Curb Ramps)

| Intersection ID: 7833 | Main Street: FLINTROCK_RD | Cross Street: GLENMOOR_DR | Location: E |

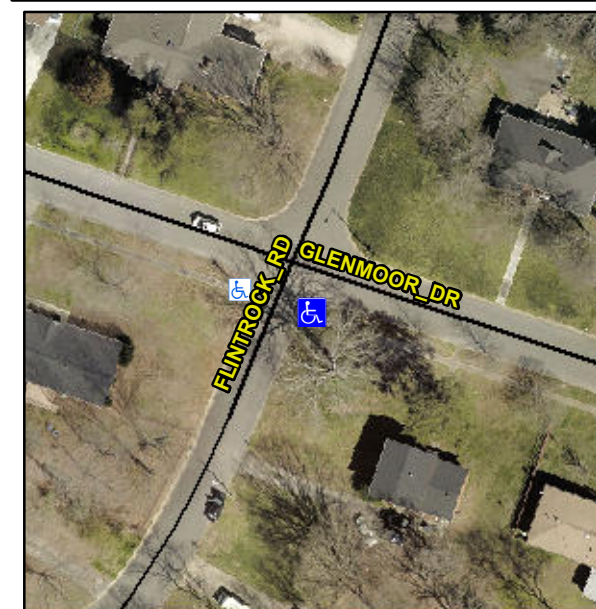
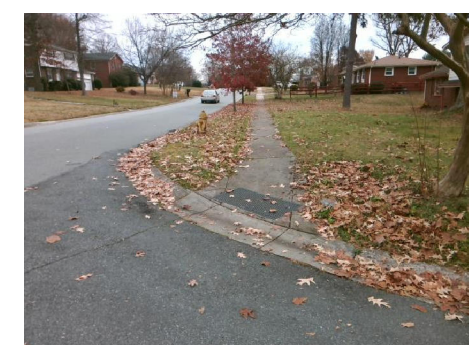
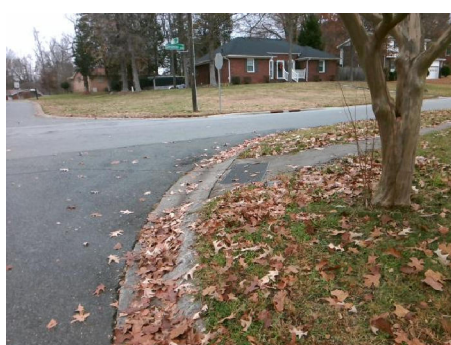
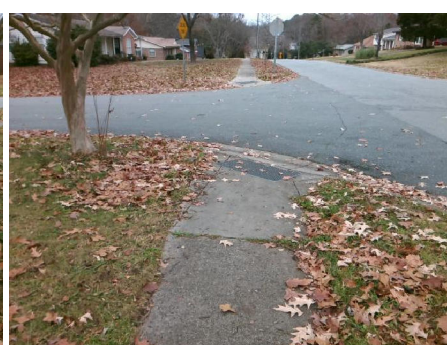
Not Found, R304.5.1, R304.2.2, R304.5.3

| Compliance | Description | Data | Compliance | Description | Data |
|---|---|---|---|---|---|
| N/A | Ramp Length (in) | 96.0 | No | Ramp Slope (%) | 8.9 |
| No | Ramp Width (in) | 42.0 | No | Ramp XSlope (%) | 5.4 |

Remove & Replace Entire Ramp.
