# Access Compliance Report

## Public Rights-of-Way

### (Curb Ramps)

Intersection ID: 19209	Main Street: LIVINGSTON_DR	Cross Street: SARDIS_RD	Location: NW
ADA ID: 9402B9FF6F50	Ramp Type: Perp	Initial Pass/Fail: Fail	Overall Compliance: No
Codes/Mitigation Info/Possible Solution		Field Measurements/Component Compliance	
Severity Score: 13.75

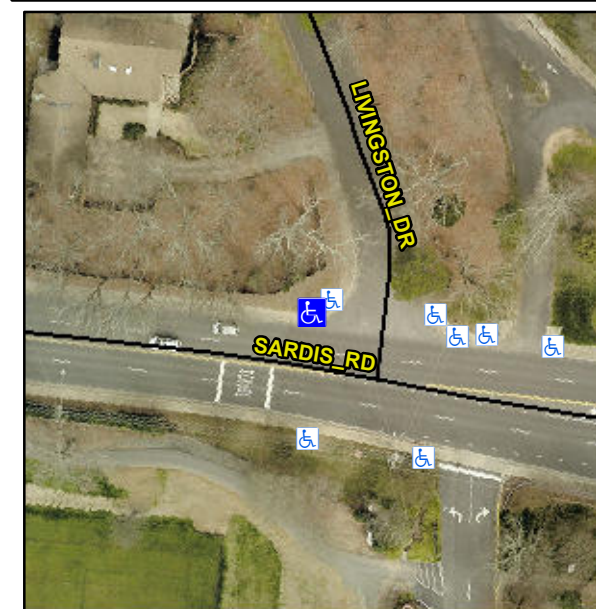
**Not Found, R304.2.2, R304.5.3**

Compliance	Description	Data	Compliance	Description	Data
N/A	Ramp Length (in)	57.0	No	Ramp Slope (%)	9.8
Yes	Ramp Width (in)	48.0	No	Ramp XSlope (%)	3.2
N/A	Flare Type LT	N/A	N/A	Flare Type RT	N/A
N/A	Flare Slope LT (%)	N/A	N/A	Flare Slope RT (%)	N/A
N/A	Flare Traversable LT?	N/A	N/A	Flare Traversable RT?	N/A
N/A	Landing Length (in)	N/A	N/A	DWS Provided?	N/A
N/A	Landing Width (in)	N/A	N/A	DWS Contrast?	N/A
N/A	Landing Slope (%)	N/A	N/A	DWS Length (in)	N/A
N/A	Landing X Slope (%)	N/A	N/A	DWS Full Width?	N/A
N/A	Landing Curb? (Y/N)	N/A	N/A	DWS Offset (in)	N/A
N/A	Shared Landing?	N/A			
N/A	Gutter Ponding?	N/A	N/A	Gutter Slope (%)	N/A
N/A	Gutter Lip Ht (in)	N/A	N/A	Gutter X Slope (%)	N/A
N/A	Painted X Walk1?	No	N/A	Painted X Walk2?	N/A
	X Walk 1 Direction	To S		X Walk 2 Direction	N/A
N/A	X Walk 1 Width (in)	N/A	N/A	X Walk 2 Width (in)	N/A
	X Walk 1 Slope (%)	3.2		X Walk 2 Slope (%)	N/A
	X Walk 1 X Slope (%)	0.2		X Walk 2 X Slope (%)	N/A

**Remove & Replace Entire Ramp.**

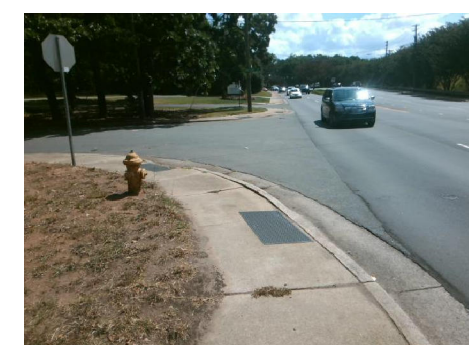
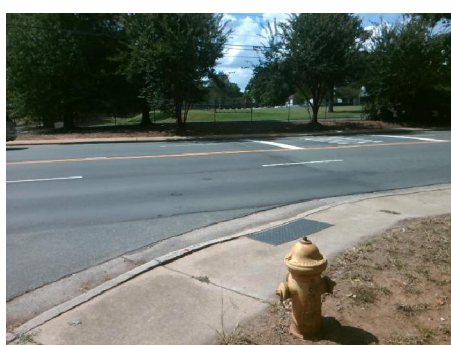
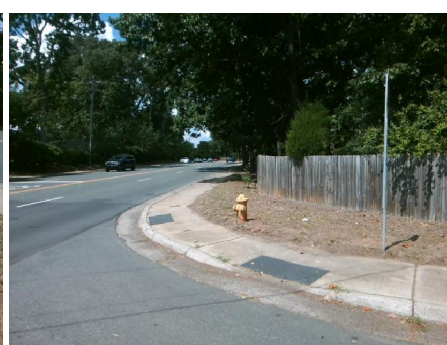
N/A	Ramp inside XWalk1?	N/A	N/A	Ramp inside XWalk2?	N/A
	Road Slope (%)	N/A	N/A	Clear Space?	N/A
	Road X Slope (%)	N/A	N/A	Clear Space to XWalk (in)	N/A
N/A	Any Obstructions?	N/A	N/A	Storm Grate/Utility Hazard?	N/A
	Obstruction Type			Storm Grate/Utility Type	
		N/A			N/A
			Yes	Surface Condition? (G/P)	Good
