Access Compliance Report

Public Rights-of-Way

(Curb Ramps)

| Intersection ID: 5992 | Main Street: GIBBON_RD | Cross Street: GRENELEFE_VILLAGE_RD | Location: SW |

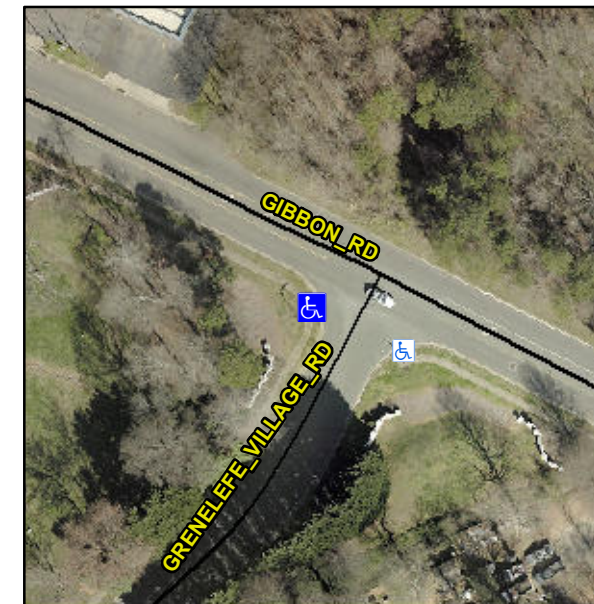
Not Found, R304.5.1, R304.2.2, R304.5.3

| Compliance | Description | Data | Compliance | Description | Data |
|---|---|---|---|---|---|
| N/A | Ramp Length (in) | 46.0 | No | Ramp Slope (%) | 8.5 |
| No | Ramp Width (in) | 47.0 | No | Ramp XSlope (%) | 2.3 |

Remove & Replace Entire Ramp.

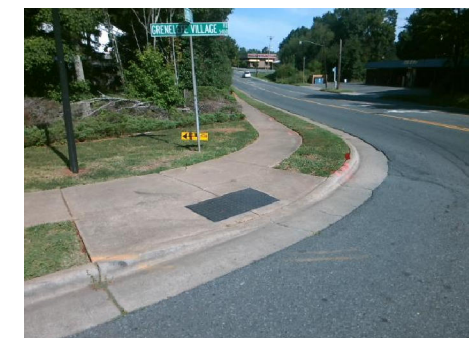
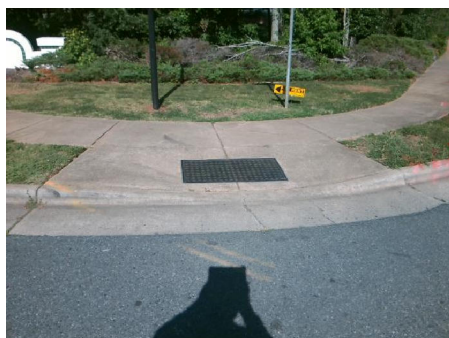
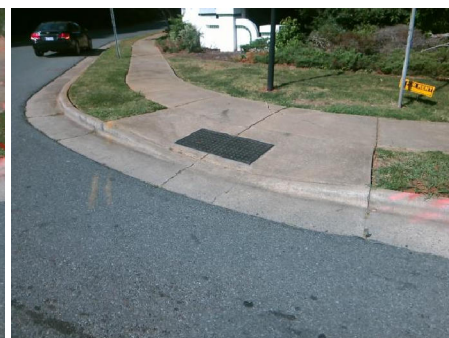
| Compliance | Description | Data | Compliance | Description | Data |
|---|---|---|---|---|---|
| | | | Yes | Surface Condition? (G/P) | Good |
