# Access Compliance Report

## Public Rights-of-Way

### (Curb Ramps)

| Intersection ID: 13118 | Main Street: E_7TH_ST | Cross Street: CENTRAL_AV | Location: E |

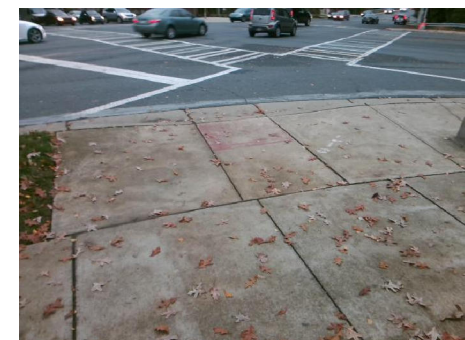
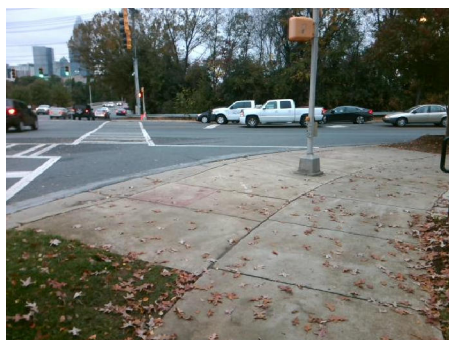
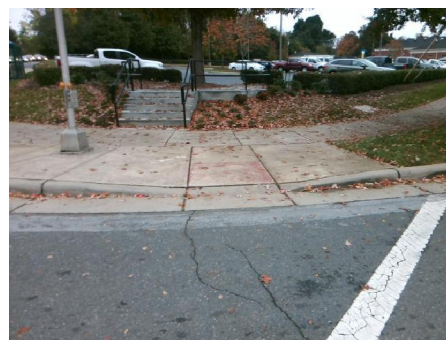
| ADA ID: 9406504BC4E2 | Ramp Type: BlendTrans1 | Initial Pass/Fail: Fail | Overall Compliance: No |
| Severity Score: 8.75 | | | |

| Compliance | Description | Data | Compliance | Description | Data |
|---|---|---|---|---|---|
| | | | Yes | Surface Condition? (G/P) | Good |

**Remove & Replace Curb Ramp With Two New Directional Ramps or Equivalent.**
