Access Compliance Report

Public Rights-of-Way

(Curb Ramps)

Intersection ID: 12268	Main Street: BELLE_TERRE_AV	Cross Street: THE_PLAZA	Location: SE
ADA ID: 940F22C63476	Ramp Type: Directional1	Initial Pass/Fail: Fail	Overall Compliance: No
		Severity Score: 12.5

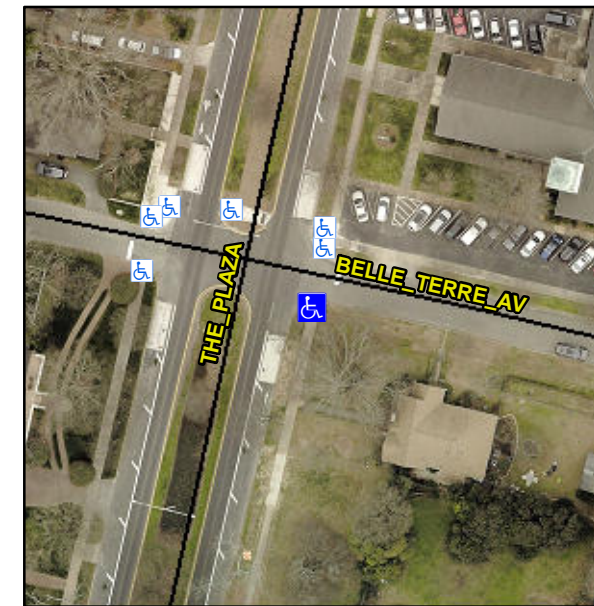
Compliance	Description	Data	Compliance	Description	Data
N/A	Ramp Length (in)	36.0	N/A	Grade Break?	N/A
Yes	Ramp Width (in)	60.0	N/A	Grade Break Slope (%)	0.0
No	Ramp Slope (%)	11.2	N/A	Grade Break XSlope (%)	0.0
Yes	Ramp XSlope (%)	1.4			
N/A	Flare Type LT	N/A	N/A	Flare Type RT	N/A
N/A	Flare Slope LT (%)	N/A	N/A	Flare Slope RT (%)	0.0
N/A	Flare Traversable LT?	N/A	N/A	Flare Traversable RT?	N/A
N/A	Landing Length (in)	0.0	N/A	DWS Provided?	N/A
N/A	Landing Width (in)	0.0	N/A	DWS Contrast?	N/A
N/A	Landing Slope (%)	0.0	N/A	DWS Length (in)	N/A
N/A	Landing X Slope (%)	0.0	N/A	DWS Full Width?	N/A
N/A	Landing Curb? (Y/N)	N/A	N/A	DWS Offset LT (in)	N/A
N/A	Shared Landing?	N/A	N/A	DWS Offset RT (in)	N/A
N/A	Gutter Ponding?	Yes	N/A	Gutter Slope (%)	N/A
N/A	Gutter Lip Ht (in)	0.0	N/A	Gutter X Slope (%)	N/A
N/A	Painted X Walk1?	No		Road Slope (%)	4.3
	X Walk 1 Direction	To N		Road X Slope (%)	0.1
	X Walk 1 Width (in)	N/A		Clear Space?	N/A

X Walk 1 Slope (%)	4.3	N/A	Clear Space to XWalk (in)	N/A
	X Walk 1 X Slope (%)	0.1	N/A	Storm Grate/Utility Hazard?	N/A
N/A	Ramp inside XWalk1?	N/A		Storm Grate/Utility Type	
N/A	Any Obstructions?	N/A			N/A
	Obstruction Type		Yes	Surface Condition? (G/P)	Good
			N/A	Curb Slope (%)	1.6

Remove & Replace Entire Ramp.
