Access Compliance Report

Public Rights-of-Way

(Curb Ramps)

Intersection ID: 11003	Main Street: CAMP_GREENE_ST	Cross Street: RINGWOOD_ST	Location: SE
ADA ID: 94150A17AD29	Ramp Type: PerpDiag	Initial Pass/Fail: Fail	Overall Compliance: No
Severity Score: 22.5			
Codes/Mitigation Info/Possible Solution		Field Measurements/Component Compliance

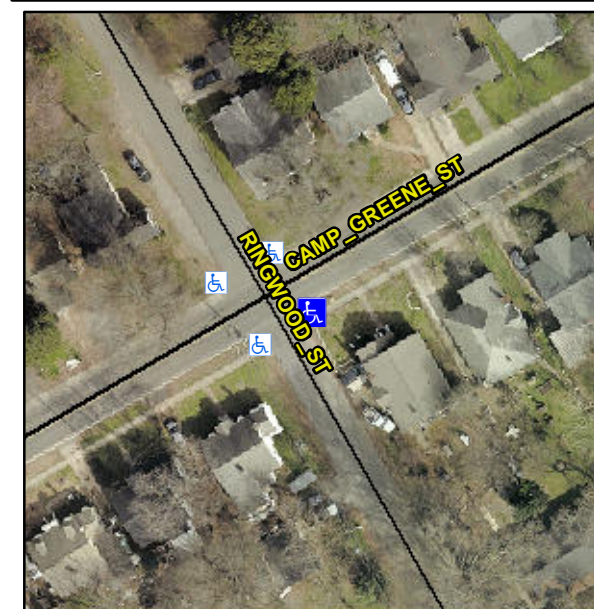
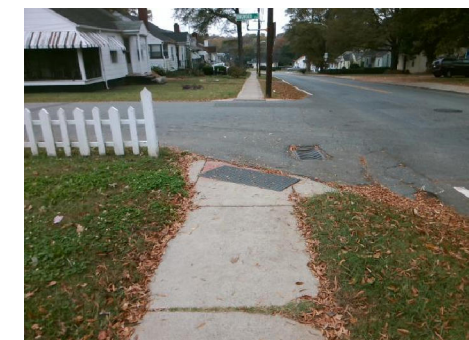
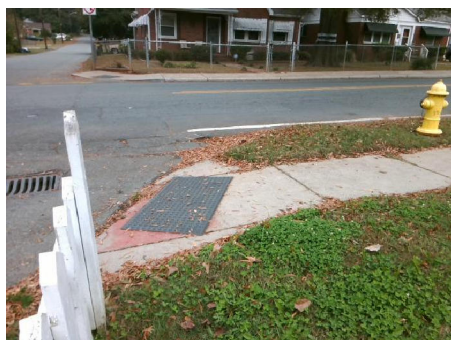
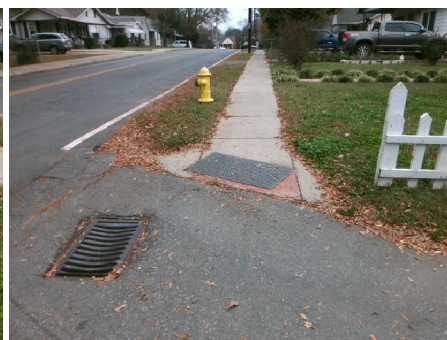
R304.5.1, R304.2.2, R304.5.3

Compliance	Description	Data	Compliance	Description	Data
N/A	Ramp Length (in)	56.0	No	Ramp Slope (%)	9.2
No	Ramp Width (in)	47.5	No	Ramp XSlope (%)	2.3
N/A	Flare Type LT	N/A	N/A	Flare Type RT	N/A
N/A	Flare Slope LT (%)	N/A	N/A	Flare Slope RT (%)	N/A
N/A	Flare Traversable LT?	N/A	N/A	Flare Traversable RT?	N/A
N/A	Landing Length (in)	N/A	N/A	DWS Provided?	N/A
N/A	Landing Width (in)	N/A	N/A	DWS Contrast?	N/A
N/A	Landing Slope (%)	N/A	N/A	DWS Length (in)	N/A
N/A	Landing X Slope (%)	N/A	N/A	DWS Full Width?	N/A
N/A	Landing Curb? (Y/N)	N/A	N/A	DWS Offset (in)	N/A
N/A	Shared Landing?	N/A			
N/A	Gutter Ponding?	N/A	N/A	Gutter Slope (%)	N/A
N/A	Gutter Lip Ht (in)	0.5	N/A	Gutter X Slope (%)	N/A
N/A	Painted X Walk1?	No	N/A	Painted X Walk2?	No
	X Walk 1 Direction	To N		X Walk 2 Direction	To W
N/A	X Walk 1 Width (in)	N/A	N/A	X Walk 2 Width (in)	N/A
	X Walk 1 Slope (%)	2.1		X Walk 2 Slope (%)	0.0
	X Walk 1 X Slope (%)	3.0		X Walk 2 X Slope (%)	1.9

N/A	Ramp inside XWalk1?	N/A	N/A	Ramp inside XWalk2?	N/A
	Road Slope (%)	5.4	N/A	Clear Space?	N/A
	Road X Slope (%)	7.0	N/A	Clear Space to XWalk (in)	N/A
N/A	Any Obstructions?	N/A	N/A	Storm Grate/Utility Hazard?	N/A
	Obstruction Type			Storm Grate/Utility Type	
		N/A			N/A
			Yes	Surface Condition? (G/P)	Good

Remove & Replace Curb Ramp With Two New Directional Ramps or Equivalent.
