Access Compliance Report Public Rights-of-Way (Curb Ramps)

Intersection ID: 7155 Main Street: GRAHAM MEADOW DR Cross Street: NORTHRIDGE VILLAGE DR Location: S Ramp Type: Perp Initial Pass/Fail: Fail **Overall Compliance: No** 1.25 ADA ID: 941965CF6BF5 **Severity Score:**

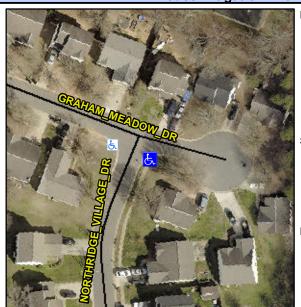
Possible Solution		Field Me
Possible Solutions:	Compl	iance Description
Remove & Replace Entire Ramp.	N/A	Ramp Length (in)
·	Yes	Ramp Width (in)
	N/A	Flare Type LT
	N/A	Flare Slope LT (%)
	N/A	Flare Traversable LT
	N/A	Landing Length (in)
Surveyor Notes:	N/A	Landing Width (in)
N/A	N/A	Landing Slope (%)
	N/A	Landing X Slope (%)
	N/A	Landing Curb? (Y/N)
	N/A	Shared Landing?
PROW/ADA:	N/A	Gutter Ponding?
Not Found, R304.5.3	N/A	Gutter Lip Ht (in)
·	N/A	Painted X Walk1?
		X Walk 1 Direction
	N/A	X Walk 1 Width (in)
		X Walk 1 Slope (%)
		X Walk 1 X Slope (%
	N/A	Ramp inside XWalk1
		Road Slope (%)
