Access Compliance Report

Public Rights-of-Way

(Curb Ramps)

Intersection ID: N/A	Main Street: SENECA_PL	Cross Street: N/A	Location: SE
ADA ID: 942D5EBB32B9	Ramp Type: Perp	Initial Pass/Fail: Fail	Overall Compliance: No
Severity Score: 42.5			
Codes/Mitigation Info/Possible Solution		Field Measurements/Component Compliance

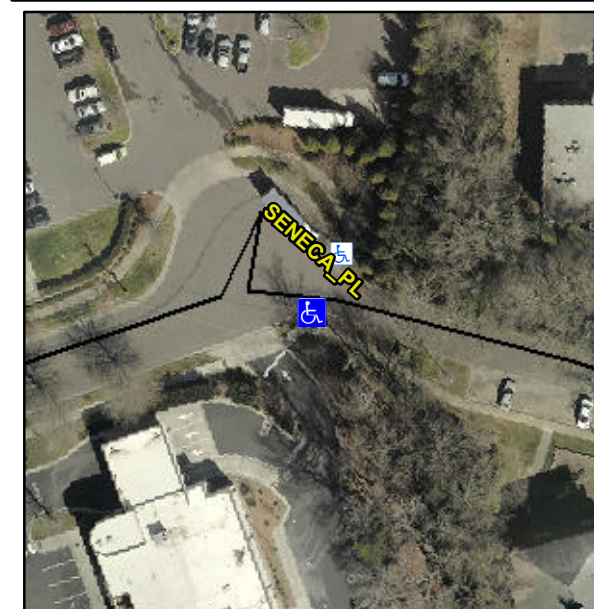
Not Found, R304.5.1, R304.2.2, R304.5.3

Compliance	Description	Data	Compliance	Description	Data
N/A	Ramp Length (in)	72.0	No	Ramp Slope (%)	10.4
No	Ramp Width (in)	32.0	No	Ramp XSlope (%)	6.4
N/A	Flare Type LT	N/A	N/A	Flare Type RT	N/A
N/A	Flare Slope LT (%)	N/A	N/A	Flare Slope RT (%)	N/A
N/A	Flare Traversable LT?	N/A	N/A	Flare Traversable RT?	N/A
N/A	Landing Length (in)	N/A	N/A	DWS Provided?	N/A
N/A	Landing Width (in)	N/A	N/A	DWS Contrast?	N/A
N/A	Landing Slope (%)	N/A	N/A	DWS Length (in)	N/A
N/A	Landing X Slope (%)	N/A	N/A	DWS Full Width?	N/A
N/A	Landing Curb? (Y/N)	N/A	N/A	DWS Offset (in)	N/A
N/A	Shared Landing?	N/A			
N/A	Gutter Ponding?	N/A	N/A	Gutter Slope (%)	N/A
N/A	Gutter Lip Ht (in)	N/A	N/A	Gutter X Slope (%)	N/A
N/A	Painted X Walk1?	No	N/A	Painted X Walk2?	N/A
	X Walk 1 Direction	To NE		X Walk 2 Direction	N/A
N/A	X Walk 1 Width (in)	N/A	N/A	X Walk 2 Width (in)	N/A
	X Walk 1 Slope (%)	7.1		X Walk 2 Slope (%)	N/A
	X Walk 1 X Slope (%)	6.2		X Walk 2 X Slope (%)	N/A

N/A	Ramp inside XWalk1?	N/A	N/A	Ramp inside XWalk2?	N/A
	Road Slope (%)	N/A	N/A	Clear Space?	N/A
	Road X Slope (%)	N/A	N/A	Clear Space to XWalk (in)	N/A
N/A	Any Obstructions?	N/A	N/A	Storm Grate/Utility Hazard?	N/A
	Obstruction Type			Storm Grate/Utility Type	
		N/A			N/A
			Yes	Surface Condition? (G/P)	Good

Remove & Replace Entire Ramp.
