Access Compliance Report Public Rights-of-Way (Curb Ramps)

Intersection ID: 2581 Main Street: COLERIDGE CT Cross Street: FAIRVISTA DR Location: SW **Overall Compliance: No** ADA ID: 942F8D77D0F0 Ramp Type: PerpDiag Initial Pass/Fail: Fail Severity Score: 21.25

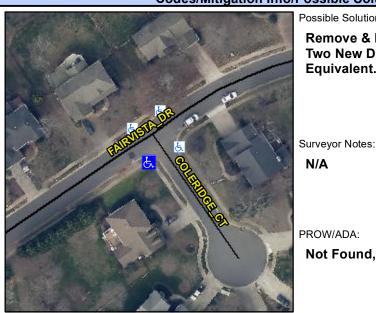
Compliance Description <u>Data</u> Compliance Description Data No N/A Ramp Length (in) 47.0 Ramp Slope (%) 9.5 No Ramp Width (in) 39.0 Yes Ramp XSlope (%) 1.1 N/A N/A Flare Type LT N/A Flare Type RT N/A N/A N/A Flare Slope RT (%) Flare Slope LT (%) N/A N/A N/A Flare Traversable LT? N/A N/A Flare Traversable RT? N/A N/A N/A N/A **DWS Provided?** N/A Landing Length (in) N/A Landing Width (in) N/A N/A **DWS Contrast?** N/A N/A N/A Landing Slope (%) N/A DWS Length (in) N/A N/A Landing X Slope (%) N/A N/A DWS Full Width? N/A N/A Landing Curb? (Y/N) N/A N/A DWS Offset (in) N/A N/A N/A Shared Landing? N/A **Gutter Ponding?** N/A N/A Gutter Slope (%) N/A N/A Gutter Lip Ht (in) N/A N/A Gutter X Slope (%) N/A N/A Painted X Walk1? No N/A Painted X Walk2? No X Walk 1 Direction To E X Walk 2 Direction To N N/A N/A X Walk 1 Width (in) X Walk 2 Width (in) N/A X Walk 1 Slope (%) X Walk 2 Slope (%) 1.3 4.6 X Walk 1 X Slope (%) 2.0 X Walk 2 X Slope (%) 3.1 N/A N/A N/A Ramp inside XWalk2? N/A Ramp inside XWalk1? Road Slope (%) 1.7 N/A Clear Space? N/A N/A Road X Slope (%) 0.1 Clear Space to XWalk (in) N/A N/A N/A Any Obstructions? N/A Storm Grate/Utility Hazard? N/A **Obstruction Type** Storm Grate/Utility Type N/A N/A Yes Surface Condition? (G/P) Good

Street 1 Name Stop Condition-Street 2 Street 2 Name Stop Condition-Street 1 **COLERIDGE CT** StopSign **FAIRVISTA DR** None Possible Solutions: Remove & Replace Curb Ramp With Two New Directional Ramps or Equivalent.

Not Found, R304.5.1, R304.2.2
