## Access Compliance Report Public Rights-of-Way (Curb Ramps)

Intersection ID: 6185 Main Street: STATESVILLE\_RD Cross Street: ORR\_ST Location: NE

ADA ID: 94454D5CA1D2 Ramp Type: Directional1 Initial Pass/Fail: Pass Overall Compliance: No Severity Score:

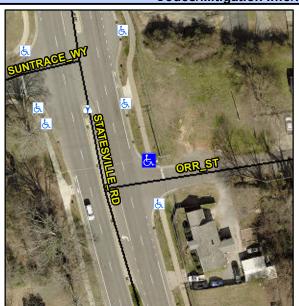
Comp	liance Description	Data	Comp	oliance Description	Data
N/A	Ramp Length (in)	73.0	Yes	Grade Break?	Yes
Yes	Ramp Width (in)	69.0	Yes	Grade Break Slope (%)	4.9
Yes	Ramp Slope (%)	5.1	Yes	Grade Break XSlope (%)	1.6
Yes	Ramp XSlope (%)	0.6			
Yes	Flare Type LT	N/A	Yes	Flare Type RT	N/A
N/A	Flare Slope LT (%)	N/A	N/A	Flare Slope RT (%)	N/A
N/A	Flare Traversable LT?	No	N/A	Flare Traversable RT?	No
Yes	Landing Length (in)	59.5	Yes	DWS Provided?	Yes
Yes	Landing Width (in)	72.0	Yes	DWS Contrast?	Yes
Yes	Landing Slope (%)	0.6	Yes	DWS Length (in)	24.0
Yes	Landing X Slope (%)	0.2	Yes	DWS Full Width?	Yes
N/A	Landing Curb? (Y/N)	N/A	Yes	DWS Offset LT (in)	2.0
N/A	Shared Landing?	No	Yes	DWS Offset RT (in)	58.0
No	Gutter Ponding?	Yes	Yes	Gutter Slope (%)	1.5
Yes	Gutter Lip Ht (in)	0.0	Yes	Gutter X Slope (%)	0.5
N/A	Painted X Walk1?	No		Road Slope (%)	0.4
	X Walk 1 Direction	To S		Road X Slope (%)	3.1
	X Walk 1 Width (in)	N/A	l	Clear Space?	Yes

X Walk 1 Slope (%)	0.4	N/A	Clear Space to XWalk (in)	N/A
	X Walk 1 X Slope (%)	3.1	No	Storm Grate/Utility Hazard?	Yes
N/A	Ramp inside XWalk1?	N/A		Storm Grate/Utility Type	
Yes	Any Obstructions?	No	GAS VAL GTR		
	Obstruction Type		Yes	Surface Condition? (G/P)	Good
		N/A	No	Curb Slope (%)	16.9

Possible Solutions:							
Remove & Replace Entire Ramp. Utility Present.							
Surveyor Notes:							
N/A							
PROW/ADA:							
Not Found, R302.7, R302.3, R402.2
