## **Access Compliance Report Public Rights-of-Way** (Curb Ramps)

Main Street: E 13TH ST **Cross Street: N DAVIDSON ST** Location: Intersection ID: 11929 SE Ramp Type: PerpDiag Initial Pass/Fail: Fail **Overall Compliance: No** ADA ID: 9449823D49FB Severity Score: 21.25

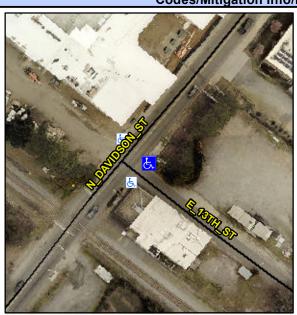
Not Found, R304.5.1, R304.5.3

N/A	Ramp Length (in)	36.0	Yes	Ramp Slope (%)
No	Ramp Width (in)	47.0	No	Ramp XSlope (%)
N/A	Flare Type LT	N/A	N/A	Flare Type RT
N/A	Flare Slope LT (%)	N/A	N/A	Flare Slope RT (%)
N/A	Flare Traversable LT?	N/A	N/A	Flare Traversable RT?
N/A	Landing Length (in)	N/A	N/A	DWS Provided?
N/A	Landing Width (in)	N/A	N/A	DWS Contrast?
N/A	Landing Slope (%)	N/A	N/A	DWS Length (in)
N/A	Landing X Slope (%)	N/A	N/A	DWS Full Width?
N/A	Landing Curb? (Y/N)	N/A	N/A	DWS Offset (in)
N/A	Shared Landing?	N/A		
N/A	Gutter Ponding?	N/A	N/A	Gutter Slope (%)
N/A	Gutter Lip Ht (in)	0.5	N/A	Gutter X Slope (%)
N/A	Painted X Walk1?	No	N/A	Painted X Walk2?
	X Walk 1 Direction	To NW		X Walk 2 Direction
N/A	X Walk 1 Width (in)	N/A	N/A	X Walk 2 Width (in)
	X Walk 1 Slope (%)	5.5		X Walk 2 Slope (%)
	X Walk 1 X Slope (%)	4.5		X Walk 2 X Slope (%)
N/A	Ramp inside XWalk1?	N/A	N/A	Ramp inside XWalk2?
	Road Slope (%)	0.2	N/A	Clear Space?
	Road X Slope (%)	8.8	N/A	Clear Space to XWalk (in)

N DAVIDSON ST Street 1 Name Stop Condition-Street 2 Street 2 Name E 13TH ST Stop Condition-Street 1 StopSign Remove & Replace Curb Ramp With Two New Directional Ramps or Equivalent.
