Access Compliance Report Public Rights-of-Way (Curb Ramps)

Intersection ID: 5967 Main Street: N_TRYON_ST Cross Street: MCCULLOUGH_DR Location: W

ADA ID: 944F1DB23B91 Ramp Type: Perp Initial Pass/Fail: Fail Overall Compliance: No Severity Score: 8.75

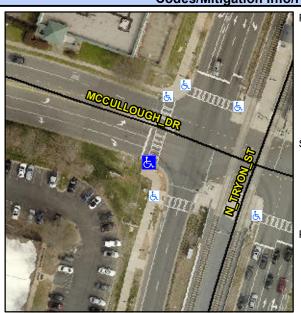
p.	N/A	Ramp Length (in)		
	No	Ramp Width (in)		
	N/A	Flare Type LT		
	N/A	Flare Slope LT (%)		
	N/A	Flare Traversable L		
	N/A	Landing Length (in)		
	N/A	Landing Width (in)		
	N/A	Landing Slope (%)		
	N/A	Landing X Slope (%		
	N/A	Landing Curb? (Y/N		
	N/A	Shared Landing?		
	N/A	Gutter Ponding?		
	N/A	Gutter Lip Ht (in)		
	N/A	Painted X Walk1?		
		X Walk 1 Direction		
	N/A	X Walk 1 Width (in)		
		X Walk 1 Slope (%)		
		X Walk 1 X Slope (%		
	N/A	Ramp inside XWalk		
		Road Slope (%)		
		Road X Slope (%)		
	N/A	Any Obstructions?		
1850.00		Obstruction Type

Possible Solutions:					
Remove & Replace Entire Ramp.					
Surveyor Notes:					
N/A					
PROW/ADA:					
R304.5.1
