# Access Compliance Report

## Public Rights-of-Way

Intersection ID: 46915	Main Street: RAISIN_TREE_LN	Cross Street: PONDEROSA_PINE_LN	Location: NW
ADA ID: 9453E70C82ED	Ramp Type: PerpDiag	Initial Pass/Fail: Fail	Overall Compliance: No
Severity Score: 25			
Codes/Mitigation Info/Possible Solution		Field Measurements/Component Compliance

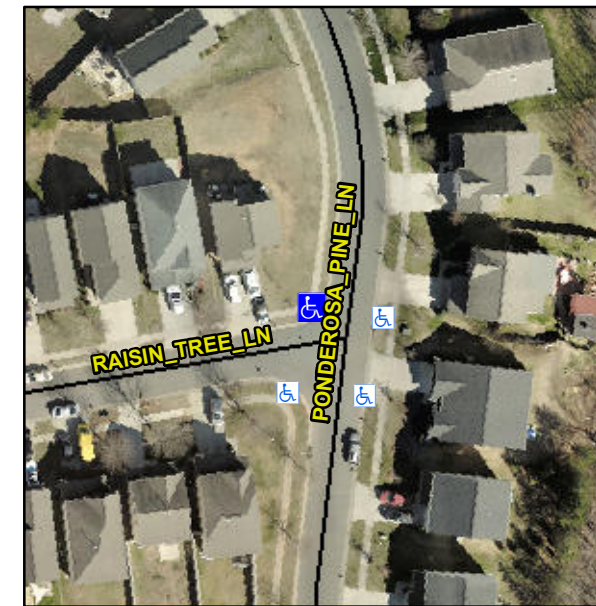
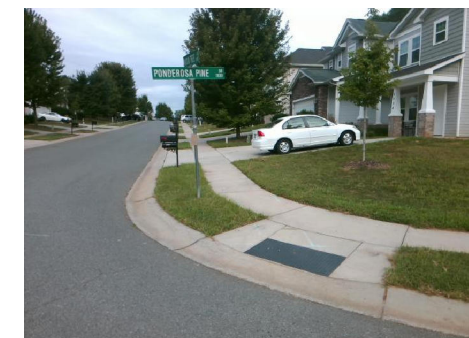
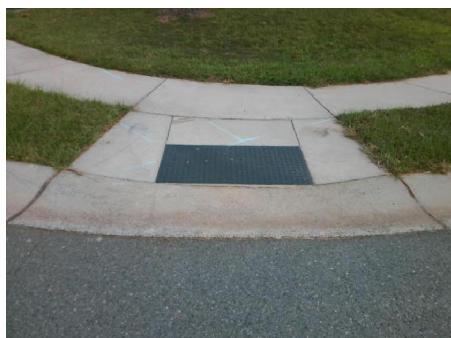
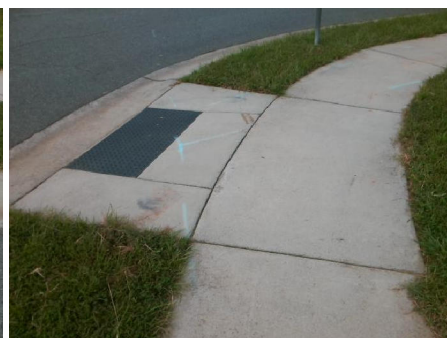
Compliance	Description	Data	Compliance	Description	Data
N/A	Ramp Length (in)	48.0	No	Ramp Slope (%)	9.9
Yes	Ramp Width (in)	48.0	No	Ramp XSlope (%)	5.1
N/A	Flare Type LT	N/A	N/A	Flare Type RT	N/A
N/A	Flare Slope LT (%)	N/A	N/A	Flare Slope RT (%)	N/A
N/A	Flare Traversable LT?	N/A	N/A	Flare Traversable RT?	N/A
N/A	Landing Length (in)	N/A	N/A	DWS Provided?	N/A
N/A	Landing Width (in)	N/A	N/A	DWS Contrast?	N/A
N/A	Landing Slope (%)	N/A	N/A	DWS Length (in)	N/A
N/A	Landing X Slope (%)	N/A	N/A	DWS Full Width?	N/A
N/A	Landing Curb? (Y/N)	N/A	N/A	DWS Offset (in)	N/A
N/A	Shared Landing?	N/A			
N/A	Gutter Ponding?	N/A	N/A	Gutter Slope (%)	N/A
N/A	Gutter Lip Ht (in)	N/A	N/A	Gutter X Slope (%)	N/A
N/A	Painted X Walk1?	No	N/A	Painted X Walk2?	No
	X Walk 1 Direction	To S		X Walk 2 Direction	To E
N/A	X Walk 1 Width (in)	N/A	N/A	X Walk 2 Width (in)	N/A
	X Walk 1 Slope (%)	3.7		X Walk 2 Slope (%)	4.6
	X Walk 1 X Slope (%)	1.0		X Walk 2 X Slope (%)	2.1

N/A	Ramp inside XWalk1?	N/A	N/A	Ramp inside XWalk2?	N/A
	Road Slope (%)	2.6	N/A	Clear Space?	N/A
	Road X Slope (%)	2.2	N/A	Clear Space to XWalk (in)	N/A
N/A	Any Obstructions?	N/A	N/A	Storm Grate/Utility Hazard?	N/A
	Obstruction Type			Storm Grate/Utility Type	
		N/A			N/A
			Yes	Surface Condition? (G/P)	Good

Possible Solutions:

**Remove & Replace Curb Ramp With Two New Directional Ramps or Equivalent.**

**R304.2.2, R304.5.3**

Total Cost: \$ 3200.00
