# Access Compliance Report

## Public Rights-of-Way

### (Curb Ramps)

Intersection ID: 45629	Main Street: SARDIS_RD_NORTH	Cross Street: GALLERIA_BV	Location: NE
ADA ID: 94677BD38DDB	Ramp Type: Perp	Initial Pass/Fail: Fail	Overall Compliance: No
Severity Score: 12.5			
Codes/Mitigation Info/Possible Solution		Field Measurements/Component Compliance

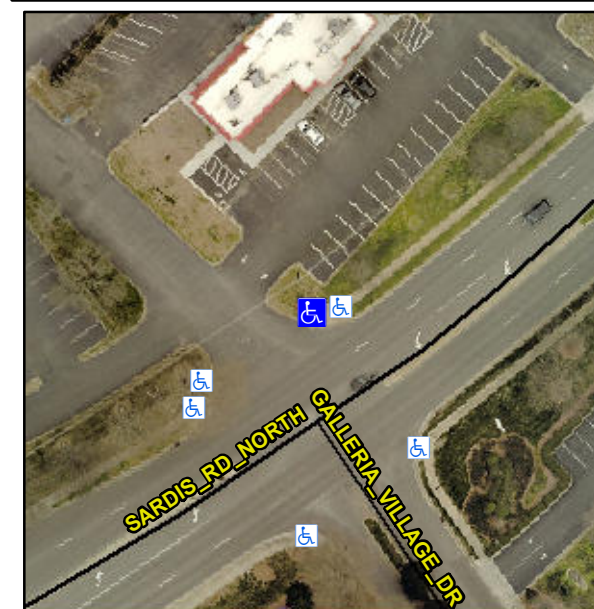
**Not Found, R304.2.2**

Compliance	Description	Data	Compliance	Description	Data
N/A	Ramp Length (in)	72.0	No	Ramp Slope (%)	9.7
Yes	Ramp Width (in)	48.0	Yes	Ramp XSlope (%)	0.7
N/A	Flare Type LT	N/A	N/A	Flare Type RT	N/A
N/A	Flare Slope LT (%)	N/A	N/A	Flare Slope RT (%)	N/A
N/A	Flare Traversable LT?	N/A	N/A	Flare Traversable RT?	N/A
N/A	Landing Length (in)	N/A	N/A	DWS Provided?	N/A
N/A	Landing Width (in)	N/A	N/A	DWS Contrast?	N/A
N/A	Landing Slope (%)	N/A	N/A	DWS Length (in)	N/A
N/A	Landing X Slope (%)	N/A	N/A	DWS Full Width?	N/A
N/A	Landing Curb? (Y/N)	N/A	N/A	DWS Offset (in)	N/A
N/A	Shared Landing?	N/A			
N/A	Gutter Ponding?	N/A	N/A	Gutter Slope (%)	N/A
N/A	Gutter Lip Ht (in)	N/A	N/A	Gutter X Slope (%)	N/A
N/A	Painted X Walk1?	No	N/A	Painted X Walk2?	N/A
	X Walk 1 Direction	To SW		X Walk 2 Direction	N/A
N/A	X Walk 1 Width (in)	N/A	N/A	X Walk 2 Width (in)	N/A
	X Walk 1 Slope (%)	0.1		X Walk 2 Slope (%)	N/A
	X Walk 1 X Slope (%)	4.3		X Walk 2 X Slope (%)	N/A

N/A	Ramp inside XWalk1?	N/A	N/A	Ramp inside XWalk2?	N/A
	Road Slope (%)	N/A	N/A	Clear Space?	N/A
	Road X Slope (%)	N/A	N/A	Clear Space to XWalk (in)	N/A
N/A	Any Obstructions?	N/A	N/A	Storm Grate/Utility Hazard?	N/A
	Obstruction Type			Storm Grate/Utility Type	
		N/A			N/A
			Yes	Surface Condition? (G/P)	Good

**Remove & Replace Entire Ramp.**

Total Cost: \$ 1850.00
