| Intersection ID: 31122 | Main Street: MILLSTREAM_RIDGE_DR | Cross Street: N/A | Location: | NE |
| ADA ID: 946B1D07E3E6 | Ramp Type: BlendTrans1 | Initial Pass/Fail: Fail | Overall Compliance: No | Severity Score: 33.75 |

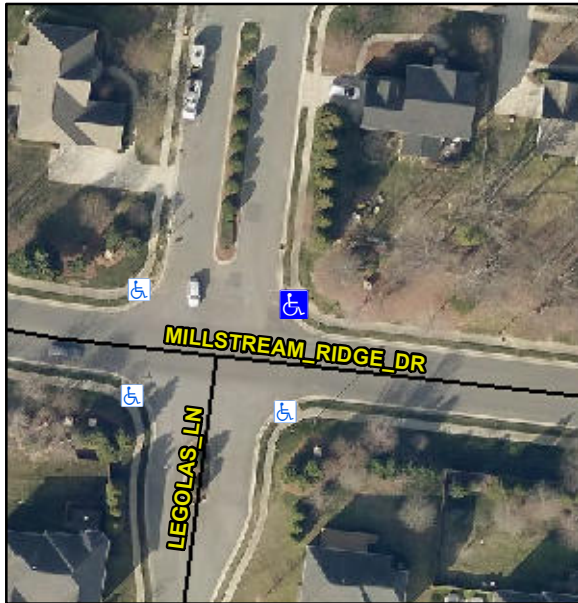
**Not Found, R304.5.1, R304.5.3**

| Compliance | Description | Data | Compliance | Description | Data |
|---|---|---|---|---|---|
| No | Ramp Width (in) | 42.0 | No | BlendTrans XSlope (%) | 10.7 |
| | | | No | Curb Slope (%) | 21.9 |

**Remove & Replace Curb Ramp With Two New Directional Ramps or Equivalent.**
