Access Compliance Report

Public Rights-of-Way

(Curb Ramps)

Intersection ID: 16513	Main Street: BILTMORE_DR	Cross Street: COLVILLE_RD	Location: SW
ADA ID: 946F2419768D	Ramp Type: Perp	Initial Pass/Fail: Fail	Overall Compliance: No
Severity Score: 13.75			
Codes/Mitigation Info/Possible Solution		Field Measurements/Component Compliance

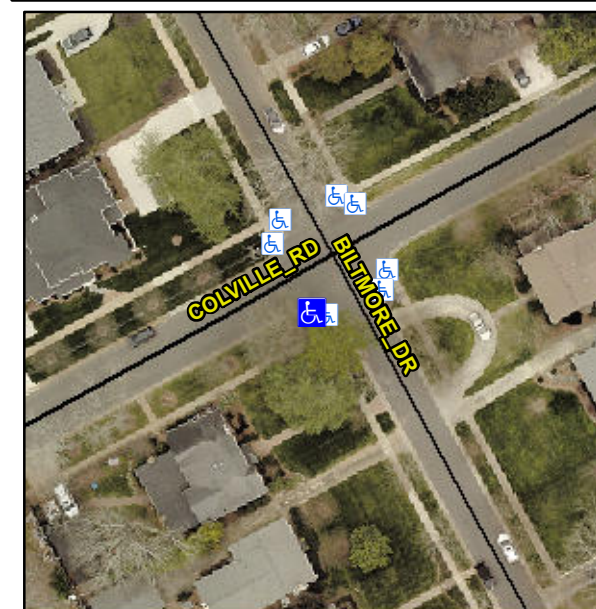
Compliance	Description	Data	Compliance	Description	Data
N/A	Ramp Length (in)	60.0	No	Ramp Slope (%)	11.1
Yes	Ramp Width (in)	48.0	No	Ramp XSlope (%)	3.2
N/A	Flare Type LT	N/A	N/A	Flare Type RT	N/A
N/A	Flare Slope LT (%)	N/A	N/A	Flare Slope RT (%)	N/A
N/A	Flare Traversable LT?	N/A	N/A	Flare Traversable RT?	N/A
N/A	Landing Length (in)	N/A	N/A	DWS Provided?	N/A
N/A	Landing Width (in)	N/A	N/A	DWS Contrast?	N/A
N/A	Landing Slope (%)	N/A	N/A	DWS Length (in)	N/A
N/A	Landing X Slope (%)	N/A	N/A	DWS Full Width?	N/A
N/A	Landing Curb? (Y/N)	N/A	N/A	DWS Offset (in)	N/A
N/A	Shared Landing?	N/A			
N/A	Gutter Ponding?	N/A	N/A	Gutter Slope (%)	N/A
N/A	Gutter Lip Ht (in)	N/A	N/A	Gutter X Slope (%)	N/A
N/A	Painted X Walk1?	No	N/A	Painted X Walk2?	N/A
	X Walk 1 Direction	To N		X Walk 2 Direction	N/A
N/A	X Walk 1 Width (in)	N/A	N/A	X Walk 2 Width (in)	N/A
	X Walk 1 Slope (%)	1.0		X Walk 2 Slope (%)	N/A
	X Walk 1 X Slope (%)	1.4		X Walk 2 X Slope (%)	N/A

N/A	Ramp inside XWalk1?	N/A	N/A	Ramp inside XWalk2?	N/A
	Road Slope (%)	N/A	N/A	Clear Space?	N/A
	Road X Slope (%)	N/A	N/A	Clear Space to XWalk (in)	N/A
N/A	Any Obstructions?	N/A	N/A	Storm Grate/Utility Hazard?	N/A
	Obstruction Type			Storm Grate/Utility Type	
		N/A			N/A
			Yes	Surface Condition? (G/P)	Good

Possible Solutions:

Remove & Replace Entire Ramp.

R304.2.2, R304.5.3

Total Cost: \$ 1850.00
