Access Compliance Report

Public Rights-of-Way

(Curb Ramps)

Intersection ID: 15725	Main Street: CLANTON_RD	Cross Street: S_TRYON_ST	Location: NW
ADA ID: 9471823B2CC9	Ramp Type: Perp	Initial Pass/Fail: Fail	Overall Compliance: No
		Severity Score: 37.5

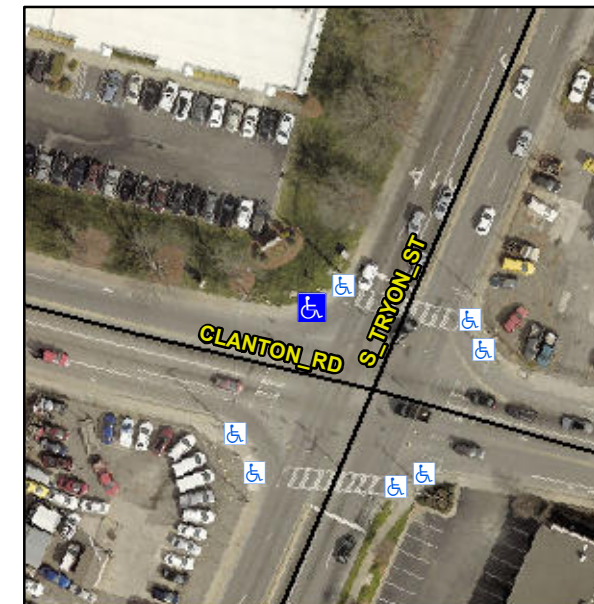
Not Found, R304.2.2, R304.5.3

Compliance	Description	Data	Compliance	Description	Data
N/A	Ramp Length (in)	59.0	No	Ramp Slope (%)	8.6
Yes	Ramp Width (in)	48.0	No	Ramp XSlope (%)	7.1
N/A	Flare Type LT	N/A	N/A	Flare Type RT	N/A
N/A	Flare Slope LT (%)	N/A	N/A	Flare Slope RT (%)	N/A
N/A	Flare Traversable LT?	N/A	N/A	Flare Traversable RT?	N/A
N/A	Landing Length (in)	N/A	N/A	DWS Provided?	N/A
N/A	Landing Width (in)	N/A	N/A	DWS Contrast?	N/A
N/A	Landing Slope (%)	N/A	N/A	DWS Length (in)	N/A
N/A	Landing X Slope (%)	N/A	N/A	DWS Full Width?	N/A
N/A	Landing Curb? (Y/N)	N/A	N/A	DWS Offset (in)	N/A
N/A	Shared Landing?	N/A			
N/A	Gutter Ponding?	N/A	N/A	Gutter Slope (%)	N/A
N/A	Gutter Lip Ht (in)	N/A	N/A	Gutter X Slope (%)	N/A
N/A	Painted X Walk1?	Yes	N/A	Painted X Walk2?	N/A
	X Walk 1 Direction	To SW		X Walk 2 Direction	N/A
N/A	X Walk 1 Width (in)	117.0	N/A	X Walk 2 Width (in)	N/A
	X Walk 1 Slope (%)	7.5		X Walk 2 Slope (%)	N/A
	X Walk 1 X Slope (%)	3.0		X Walk 2 X Slope (%)	N/A

N/A	Ramp inside XWalk1?	Yes	N/A	Ramp inside XWalk2?	N/A
	Road Slope (%)	N/A	N/A	Clear Space?	N/A
	Road X Slope (%)	N/A	N/A	Clear Space to XWalk (in)	N/A
N/A	Any Obstructions?	N/A	N/A	Storm Grate/Utility Hazard?	N/A
	Obstruction Type			Storm Grate/Utility Type	
		N/A			N/A
			Yes	Surface Condition? (G/P)	Good

Possible Solutions:

Remove & Replace Entire Ramp.
