Access Compliance Report

Public Rights-of-Way

(Curb Ramps)

Intersection ID: 24123	Main Street: SOUTH_BRIDGE_CR	Cross Street: SOUTH_POINT_BV	Location: SW
ADA ID: 947DDF94435E	Ramp Type: Perp	Initial Pass/Fail: Fail	Overall Compliance: No
Severity Score: 1.25			
Codes/Mitigation Info/Possible Solution		Field Measurements/Component Compliance

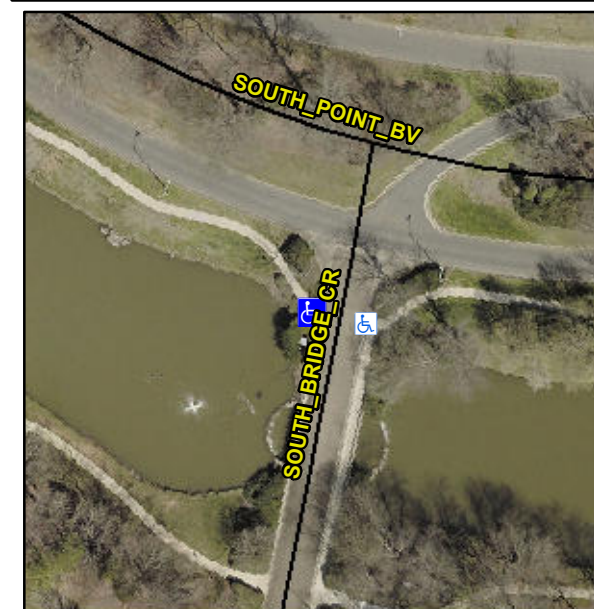
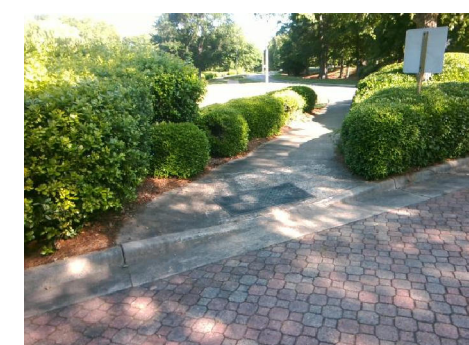
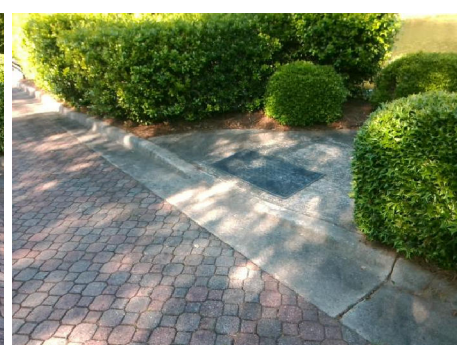
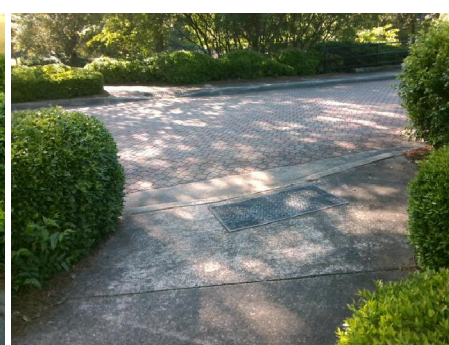
Not Found, R304.5.3

Compliance	Description	Data	Compliance	Description	Data
N/A	Ramp Length (in)	50.0	Yes	Ramp Slope (%)	6.3
Yes	Ramp Width (in)	48.0	No	Ramp XSlope (%)	2.3
N/A	Flare Type LT	N/A	N/A	Flare Type RT	N/A
N/A	Flare Slope LT (%)	N/A	N/A	Flare Slope RT (%)	N/A
N/A	Flare Traversable LT?	N/A	N/A	Flare Traversable RT?	N/A
N/A	Landing Length (in)	N/A	N/A	DWS Provided?	N/A
N/A	Landing Width (in)	N/A	N/A	DWS Contrast?	N/A
N/A	Landing Slope (%)	N/A	N/A	DWS Length (in)	N/A
N/A	Landing X Slope (%)	N/A	N/A	DWS Full Width?	N/A
N/A	Landing Curb? (Y/N)	N/A	N/A	DWS Offset (in)	N/A
N/A	Shared Landing?	N/A			
N/A	Gutter Ponding?	N/A	N/A	Gutter Slope (%)	N/A
N/A	Gutter Lip Ht (in)	N/A	N/A	Gutter X Slope (%)	N/A
N/A	Painted X Walk1?	No	N/A	Painted X Walk2?	N/A
	X Walk 1 Direction	To E		X Walk 2 Direction	N/A
N/A	X Walk 1 Width (in)	N/A	N/A	X Walk 2 Width (in)	N/A
	X Walk 1 Slope (%)	2.2		X Walk 2 Slope (%)	N/A
	X Walk 1 X Slope (%)	2.6		X Walk 2 X Slope (%)	N/A

N/A	Ramp inside XWalk1?	N/A	N/A	Ramp inside XWalk2?	N/A
	Road Slope (%)	N/A	N/A	Clear Space?	N/A
	Road X Slope (%)	N/A	N/A	Clear Space to XWalk (in)	N/A
N/A	Any Obstructions?	N/A	N/A	Storm Grate/Utility Hazard?	N/A
	Obstruction Type			Storm Grate/Utility Type	
		N/A			N/A
		Yes		Surface Condition? (G/P)	Good

Possible Solutions:

Remove & Replace Entire Ramp.
