# Access Compliance Report

## Public Rights-of-Way

### (Curb Ramps)

Intersection ID: 8437	Main Street: OLD_CONCORD_RD	Cross Street: ORR_RD	Location:	E
ADA ID: 94834F6169C6	Ramp Type: Perp	Initial Pass/Fail: Fail	Overall Compliance: No	Severity Score: 37.5

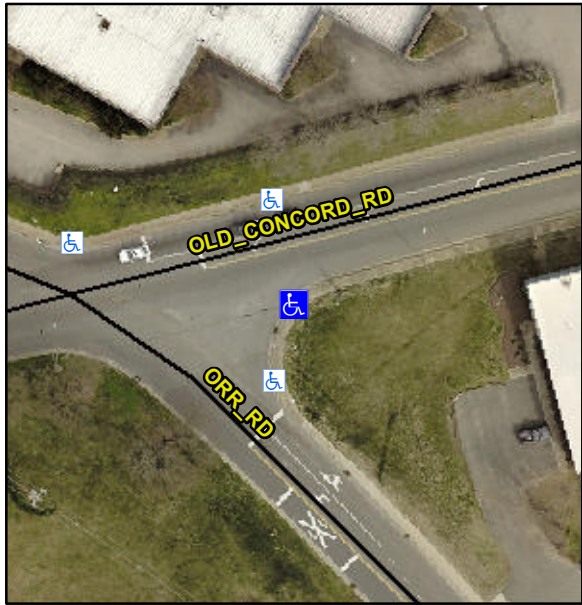
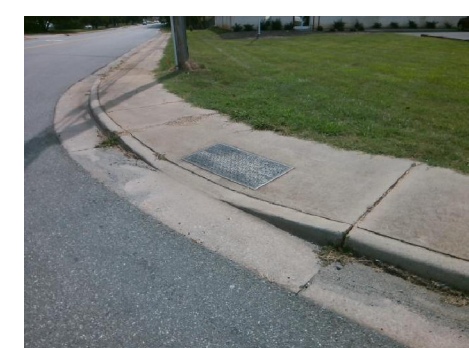
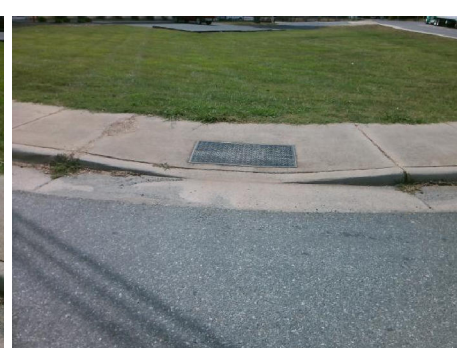
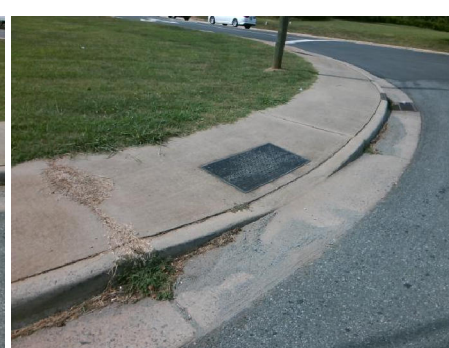
Possible Solutions:		Compliance	Description	Data	Compliance	Description	Data
	Remove & Replace Entire Ramp.		N/A	Ramp Length (in)	60.0	No	Ramp Slope (%)	10.2
			Yes	Ramp Width (in)	48.0	No	Ramp XSlope (%)	10.3
			N/A	Flare Type LT	N/A	N/A	Flare Type RT	N/A
			N/A	Flare Slope LT (%)	N/A	N/A	Flare Slope RT (%)	N/A
			N/A	Flare Traversable LT?	N/A	N/A	Flare Traversable RT?	N/A
			N/A	Landing Length (in)	N/A	N/A	DWS Provided?	N/A
			N/A	Landing Width (in)	N/A	N/A	DWS Contrast?	N/A
			N/A	Landing Slope (%)	N/A	N/A	DWS Length (in)	N/A
			N/A	Landing X Slope (%)	N/A	N/A	DWS Full Width?	N/A
Surveyor Notes:			N/A	Landing Curb? (Y/N)	N/A	N/A	DWS Offset (in)	N/A
N/A			N/A	Shared Landing?	N/A			
PROW/ADA:			N/A	Gutter Ponding?	N/A	N/A	Gutter Slope (%)	N/A
Not Found, R304.2.2, R304.5.3			N/A	Gutter Lip Ht (in)	1.0	N/A	Gutter X Slope (%)	N/A

N/A	Painted X Walk1?	No	N/A	Painted X Walk2?	N/A
				X Walk 1 Direction	To N		X Walk 2 Direction	N/A
			N/A	X Walk 1 Width (in)	N/A	N/A	X Walk 2 Width (in)	N/A
				X Walk 1 Slope (%)	3.8		X Walk 2 Slope (%)	N/A
				X Walk 1 X Slope (%)	3.7		X Walk 2 X Slope (%)	N/A
			N/A	Ramp inside XWalk1?	N/A	N/A	Ramp inside XWalk2?	N/A
				Road Slope (%)	N/A	N/A	Clear Space?	N/A
				Road X Slope (%)	N/A	N/A	Clear Space to XWalk (in)	N/A
			N/A	Any Obstructions?	N/A	N/A	Storm Grate/Utility Hazard?	N/A
				Obstruction Type			Storm Grate/Utility Type	
						N/A		N/A
						Yes	Surface Condition? (G/P)	Good
