# Access Compliance Report

## Public Rights-of-Way

### (Curb Ramps)

Intersection ID: 5967	Main Street: N_TRYON_ST	Cross Street: MCCULLOUGH_DR	Location: NE
ADA ID: 948AFDAF576F	Ramp Type: BlendTrans1	Initial Pass/Fail: Fail	Overall Compliance: No
Severity Score: 8.75			
Codes/Mitigation Info/Possible Solution		Field Measurements/Component Compliance

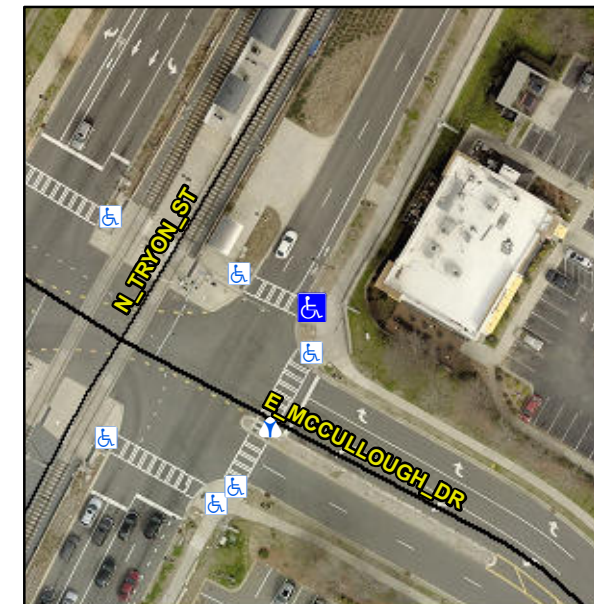
**Not Found, R304.5.1**

Compliance	Description	Data	Compliance	Description	Data
N/A	Ramp Length (in)	104.0	Yes	BlendTrans Slope (%)	3.3
No	Ramp Width (in)	47.5	Yes	BlendTrans XSlope (%)	0.8
N/A	Flare Type LT	N/A	N/A	Flare Type RT	N/A
N/A	Flare Slope LT (%)	N/A	N/A	Flare Slope RT (%)	N/A
N/A	Flare Traversable LT?	N/A	N/A	Flare Traversable RT?	N/A
N/A	Landing Length (in)	N/A	N/A	DWS Provided?	N/A
N/A	Landing Width (in)	N/A	N/A	DWS Contrast?	N/A
N/A	Landing Slope (%)	N/A	N/A	DWS Length (in)	N/A
N/A	Landing X Slope (%)	N/A	N/A	DWS Full Width?	N/A
N/A	Landing Curb? (Y/N)	N/A	N/A	DWS Offset (in)	N/A
N/A	Shared Landing?	N/A			
N/A	Gutter Ponding?	N/A	N/A	Gutter Slope (%)	N/A
N/A	Gutter Lip Ht (in)	1.5	N/A	Gutter X Slope (%)	N/A
N/A	Painted X Walk1?	No	N/A	Painted X Walk2?	N/A
	X Walk 1 Direction	To NW		X Walk 2 Direction	N/A
	X Walk 1 Width (in)	N/A		X Walk 2 Width (in)	N/A
	X Walk 1 Slope (%)	1.9		X Walk 2 Slope (%)	N/A
	X Walk 1 X Slope (%)	0.7		X Walk 2 X Slope (%)	N/A

N/A	Ramp inside XWalk1?	N/A	N/A	Ramp inside XWalk2?	N/A
	Road Slope (%)	0.7		Clear Space?	N/A
	Road X Slope (%)	1.9	N/A	Clear Space to XWalk (in)	N/A
N/A	Any Obstructions?	N/A	N/A	Storm Grate/Utility Hazard?	N/A
	Obstruction Type			Storm Grate/Utility Type	
		N/A			N/A
			Yes	Surface Condition? (G/P)	Good
			No	Curb Slope (%)	12.0

**Remove & Replace Curb Ramp With Two New Directional Ramps or Equivalent.**
