| Intersection ID: 9779 | Main Street: CAMPUS_ST | Cross Street: CEMETERY_ST | Location: | SW |
| ADA ID: 948FD2B791C5 | Ramp Type: PerpDiag | Initial Pass/Fail: Fail | Overall Compliance: No | Severity Score: 35 |

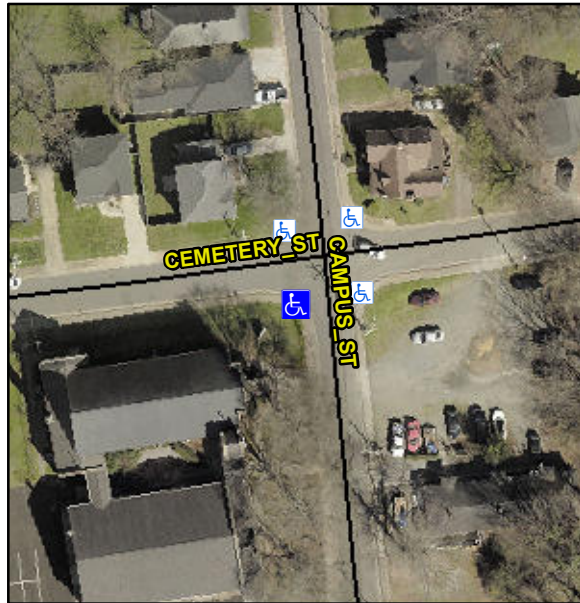
**Not Found, R304.5.1, R304.2.2,
R304.5.3**

| Compliance | Description | Data | Compliance | Description | Data |
|---|---|---|---|---|---|
| N/A | Ramp Length (in) | 47.0 | No | Ramp Slope (%) | 12.4 |
| No | Ramp Width (in) | 40.0 | No | Ramp XSlope (%) | 2.2 |

Remove & Replace Curb Ramp With Two New Directional Ramps or Equivalent.
