Access Compliance Report

Public Rights-of-Way

(Curb Ramps)

Intersection ID: 19432	Main Street: REXFORD_RD	Cross Street: COCA-COLA PLAZA	Location: SW
ADA ID: 94B2578C51D9	Ramp Type: Perp	Initial Pass/Fail: Fail	Overall Compliance: No
		Severity Score: 22.5

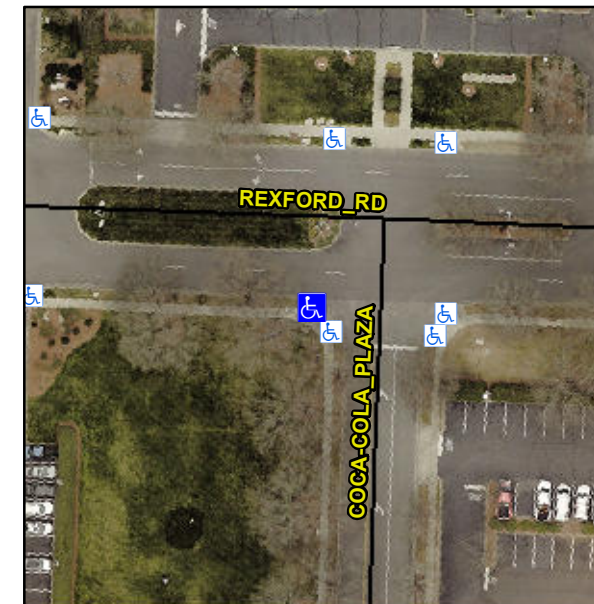
R304.5.1, R304.2.2, R304.5.3

Compliance	Description	Data	Compliance	Description	Data
N/A	Ramp Length (in)	129.5	No	Ramp Slope (%)	9.2
No	Ramp Width (in)	46.0	No	Ramp XSlope (%)	3.0
N/A	Flare Type LT	N/A	N/A	Flare Type RT	N/A
N/A	Flare Slope LT (%)	N/A	N/A	Flare Slope RT (%)	N/A
N/A	Flare Traversable LT?	N/A	N/A	Flare Traversable RT?	N/A
N/A	Landing Length (in)	N/A	N/A	DWS Provided?	N/A
N/A	Landing Width (in)	N/A	N/A	DWS Contrast?	N/A
N/A	Landing Slope (%)	N/A	N/A	DWS Length (in)	N/A
N/A	Landing X Slope (%)	N/A	N/A	DWS Full Width?	N/A
N/A	Landing Curb? (Y/N)	N/A	N/A	DWS Offset (in)	N/A
N/A	Shared Landing?	N/A			
N/A	Gutter Ponding?	N/A	N/A	Gutter Slope (%)	N/A
N/A	Gutter Lip Ht (in)	N/A	N/A	Gutter X Slope (%)	N/A
N/A	Painted X Walk1?	No	N/A	Painted X Walk2?	N/A
	X Walk 1 Direction	To N		X Walk 2 Direction	N/A
N/A	X Walk 1 Width (in)	N/A	N/A	X Walk 2 Width (in)	N/A
	X Walk 1 Slope (%)	3.3		X Walk 2 Slope (%)	N/A
	X Walk 1 X Slope (%)	2.1		X Walk 2 X Slope (%)	N/A

Remove & Replace Entire Ramp.

Total Cost: \$ 1850.00
