Access Compliance Report

Public Rights-of-Way

(Curb Ramps)

Intersection ID: 28846	Main Street: BRENLY_CT	Cross Street: FAIRCHASE_AV	Location:	S
ADA ID: 94B5172AD90D	Ramp Type: BlendTrans1	Initial Pass/Fail: Fail	Overall Compliance: No	Severity Score: 10

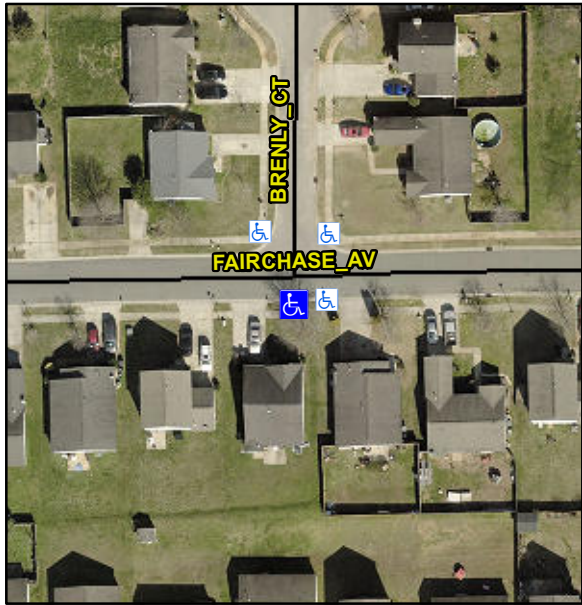
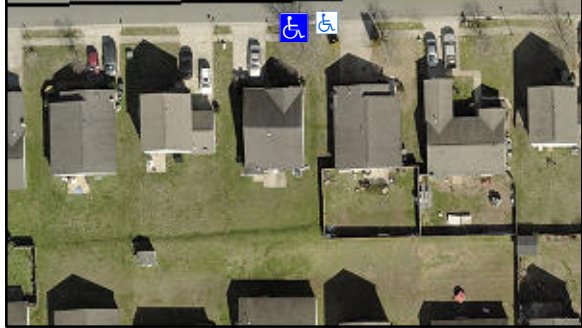
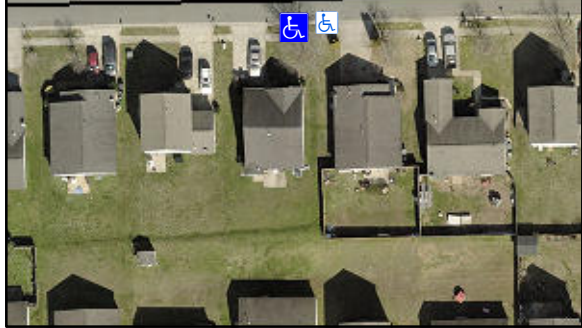
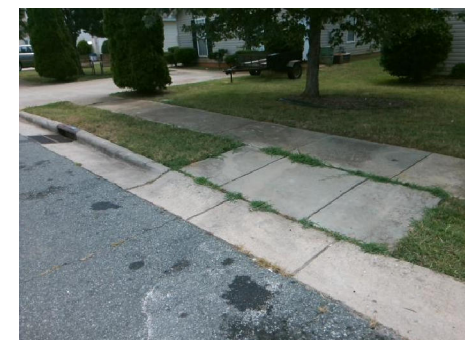
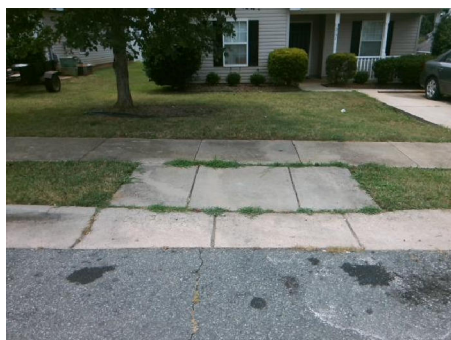
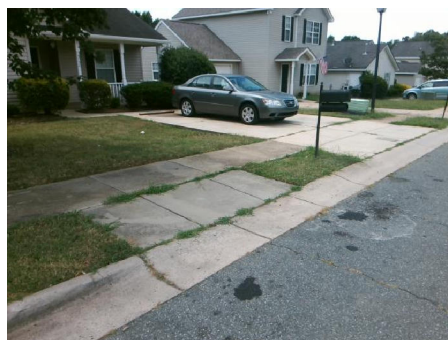
Possible Solutions:		Compliance	Description	Data	Compliance	Description	Data
	Remove & Replace Curb Ramp With Two New Directional Ramps or Equivalent.		N/A	Ramp Length (in)	48.0	Yes	BlendTrans Slope (%)	4.9
			No	Ramp Width (in)	44.0	No	BlendTrans XSlope (%)	3.1
			N/A	Flare Type LT	N/A	N/A	Flare Type RT	N/A
			N/A	Flare Slope LT (%)	N/A	N/A	Flare Slope RT (%)	N/A
			N/A	Flare Traversable LT?	N/A	N/A	Flare Traversable RT?	N/A
			N/A	Landing Length (in)	N/A	N/A	DWS Provided?	N/A
			N/A	Landing Width (in)	N/A	N/A	DWS Contrast?	N/A
			N/A	Landing Slope (%)	N/A	N/A	DWS Length (in)	N/A
			N/A	Landing X Slope (%)	N/A	N/A	DWS Full Width?	N/A

Surveyor Notes:		N/A	Landing Curb? (Y/N)	N/A	N/A	DWS Offset (in)	N/A
	N/A		N/A	Shared Landing?	N/A			
	PROW/ADA:		N/A	Gutter Ponding?	N/A	N/A	Gutter Slope (%)	N/A
	Not Found, R304.5.1, R304.5.3		N/A	Gutter Lip Ht (in)	N/A	N/A	Gutter X Slope (%)	N/A

N/A	Painted X Walk1?	No	N/A	Painted X Walk2?	N/A
				X Walk 1 Direction	To N		X Walk 2 Direction	N/A
				X Walk 1 Width (in)	N/A		X Walk 2 Width (in)	N/A
				X Walk 1 Slope (%)	4.6		X Walk 2 Slope (%)	N/A
				X Walk 1 X Slope (%)	1.9		X Walk 2 X Slope (%)	N/A
			N/A	Ramp inside XWalk1?	N/A	N/A	Ramp inside XWalk2?	N/A

Road Slope (%)	1.9		Clear Space?	N/A
				Road X Slope (%)	4.6	N/A	Clear Space to XWalk (in)	N/A
			N/A	Any Obstructions?	N/A	N/A	Storm Grate/Utility Hazard?	N/A
				Obstruction Type			Storm Grate/Utility Type	
					N/A			N/A
						Yes	Surface Condition? (G/P)	Good
						No	Curb Slope (%)	12.4

Total Cost: \$ 3200.00
