# Access Compliance Report

## Public Rights-of-Way

### (Curb Ramps)

Intersection ID: 18178	Main Street: HODGSON_RD	Cross Street: RANDOLPH_RD	Location: NW
ADA ID: 94C061135034	Ramp Type: PerpDiag	Initial Pass/Fail: Fail	Overall Compliance: No
Severity Score: 21.25			
Codes/Mitigation Info/Possible Solution		Field Measurements/Component Compliance

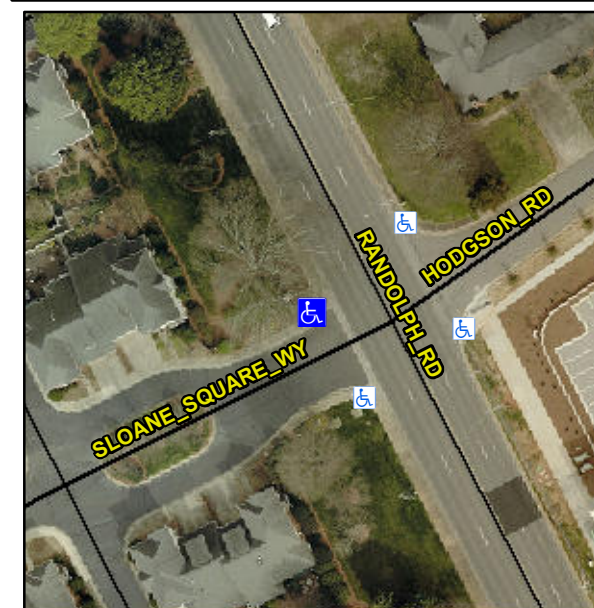
Compliance	Description	Data	Compliance	Description	Data
N/A	Ramp Length (in)	28.0	No	Ramp Slope (%)	9.9
No	Ramp Width (in)	45.0	Yes	Ramp XSlope (%)	0.6
N/A	Flare Type LT	N/A	N/A	Flare Type RT	N/A
N/A	Flare Slope LT (%)	N/A	N/A	Flare Slope RT (%)	N/A
N/A	Flare Traversable LT?	N/A	N/A	Flare Traversable RT?	N/A
N/A	Landing Length (in)	N/A	N/A	DWS Provided?	N/A
N/A	Landing Width (in)	N/A	N/A	DWS Contrast?	N/A
N/A	Landing Slope (%)	N/A	N/A	DWS Length (in)	N/A
N/A	Landing X Slope (%)	N/A	N/A	DWS Full Width?	N/A
N/A	Landing Curb? (Y/N)	N/A	N/A	DWS Offset (in)	N/A
N/A	Shared Landing?	N/A			
N/A	Gutter Ponding?	N/A	N/A	Gutter Slope (%)	N/A
N/A	Gutter Lip Ht (in)	N/A	N/A	Gutter X Slope (%)	N/A
N/A	Painted X Walk1?	No	N/A	Painted X Walk2?	No
	X Walk 1 Direction	To SE		X Walk 2 Direction	To NE
N/A	X Walk 1 Width (in)	N/A	N/A	X Walk 2 Width (in)	N/A
	X Walk 1 Slope (%)	2.7		X Walk 2 Slope (%)	3.7
	X Walk 1 X Slope (%)	4.1		X Walk 2 X Slope (%)	0.5

N/A	Ramp inside XWalk1?	N/A	N/A	Ramp inside XWalk2?	N/A
	Road Slope (%)	1.9	N/A	Clear Space?	N/A
	Road X Slope (%)	1.3	N/A	Clear Space to XWalk (in)	N/A
N/A	Any Obstructions?	N/A	N/A	Storm Grate/Utility Hazard?	N/A
	Obstruction Type			Storm Grate/Utility Type	
		N/A			N/A
			Yes	Surface Condition? (G/P)	Good

**Remove & Replace Curb Ramp With Two New Directional Ramps or Equivalent.**

**R304.5.1, R304.2.2**
