Access Compliance Report

Public Rights-of-Way

(Curb Ramps)

Intersection ID: 5966	Main Street: SUNSTONE_DR	Cross Street: STATESVILLE_RD	Location: SE
ADA ID: 94C11DBE3044	Ramp Type: Perp	Initial Pass/Fail: Fail	Overall Compliance: No
Codes/Mitigation Info/Possible Solution		Field Measurements/Component Compliance	
Severity Score: 21.25

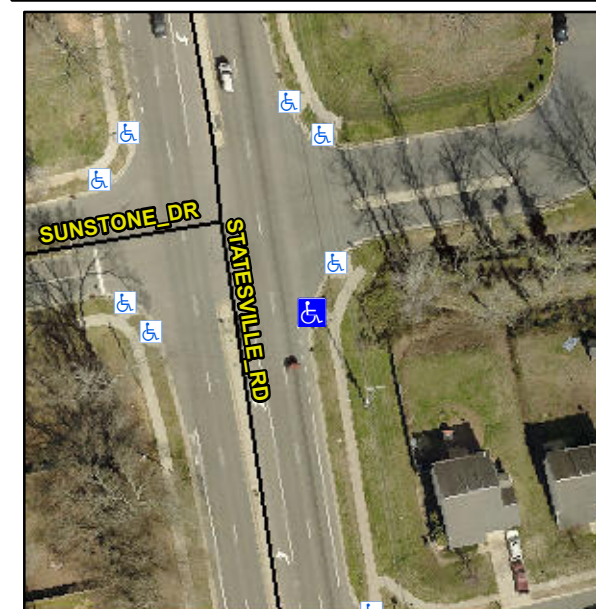
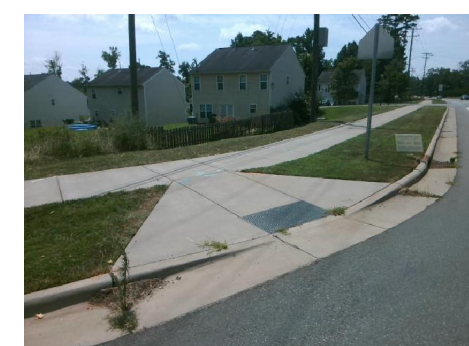
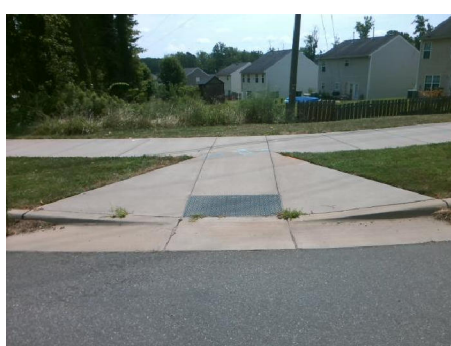
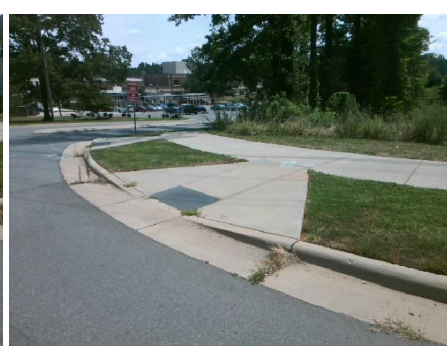
Not Found, R304.5.1, R304.2.2

Compliance	Description	Data	Compliance	Description	Data
N/A	Ramp Length (in)	104.5	No	Ramp Slope (%)	8.4
No	Ramp Width (in)	45.5	Yes	Ramp XSlope (%)	0.8
N/A	Flare Type LT	N/A	N/A	Flare Type RT	N/A
N/A	Flare Slope LT (%)	N/A	N/A	Flare Slope RT (%)	N/A
N/A	Flare Traversable LT?	N/A	N/A	Flare Traversable RT?	N/A
N/A	Landing Length (in)	N/A	N/A	DWS Provided?	N/A
N/A	Landing Width (in)	N/A	N/A	DWS Contrast?	N/A
N/A	Landing Slope (%)	N/A	N/A	DWS Length (in)	N/A
N/A	Landing X Slope (%)	N/A	N/A	DWS Full Width?	N/A
N/A	Landing Curb? (Y/N)	N/A	N/A	DWS Offset (in)	N/A
N/A	Shared Landing?	N/A			
N/A	Gutter Ponding?	N/A	N/A	Gutter Slope (%)	N/A
N/A	Gutter Lip Ht (in)	N/A	N/A	Gutter X Slope (%)	N/A
N/A	Painted X Walk1?	No	N/A	Painted X Walk2?	N/A
	X Walk 1 Direction	To W		X Walk 2 Direction	N/A
N/A	X Walk 1 Width (in)	N/A	N/A	X Walk 2 Width (in)	N/A
	X Walk 1 Slope (%)	1.4		X Walk 2 Slope (%)	N/A
	X Walk 1 X Slope (%)	1.2		X Walk 2 X Slope (%)	N/A

N/A	Ramp inside XWalk1?	N/A	N/A	Ramp inside XWalk2?	N/A
	Road Slope (%)	N/A	N/A	Clear Space?	N/A
	Road X Slope (%)	N/A	N/A	Clear Space to XWalk (in)	N/A
N/A	Any Obstructions?	N/A	N/A	Storm Grate/Utility Hazard?	N/A
	Obstruction Type			Storm Grate/Utility Type	
		N/A			N/A
			Yes	Surface Condition? (G/P)	Good

Possible Solutions:

Remove & Replace Entire Ramp.
